# Access Compliance Report

## Public Rights-of-Way

### (Curb Ramps)

| Intersection ID: N/A | Main Street: BALLANTYNE COMMONS PKWY | Cross Street: N/A | Location: E |

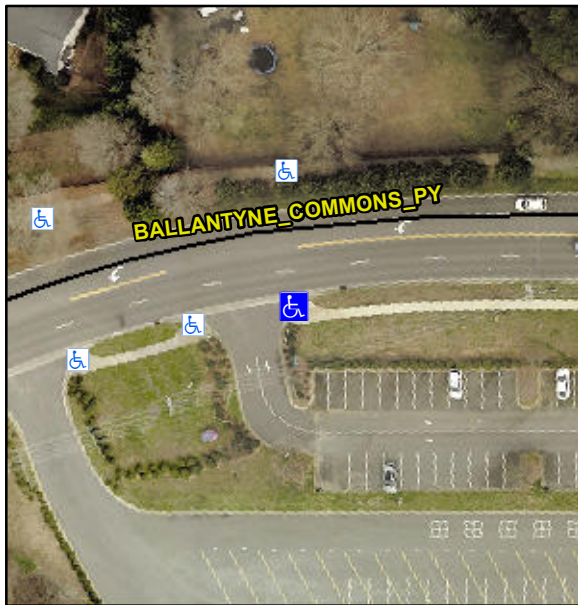
| ADA ID: 8A899598AA0B | Ramp Type: PerpDiag | Initial Pass/Fail: Fail | Overall Compliance: No |
| Severity Score: 12.5 | | | |

**Not Found, R304.2.2**

| Compliance | Description | Data | Compliance | Description | Data |
|---|---|---|---|---|---|
| N/A | Ramp Length (in) | 48.0 | No | Ramp Slope (%) | 11.2 |

**Remove & Replace Curb Ramp With Two New Directional Ramps or Equivalent.**

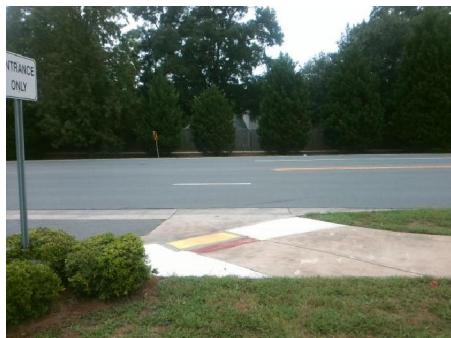
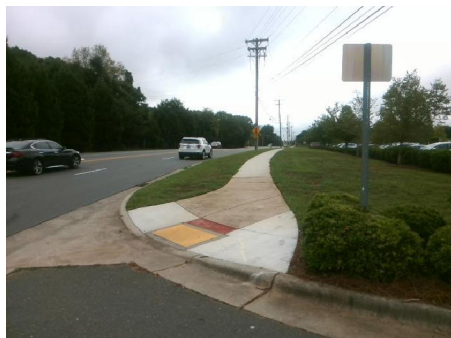
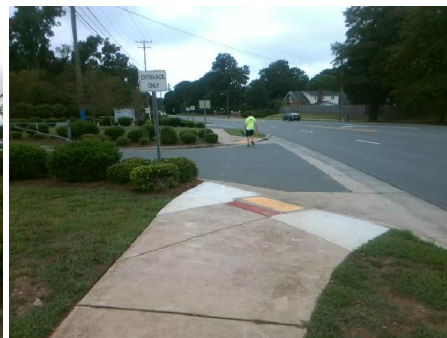
| Compliance | Description | Data | Compliance | Description | Data |
|---|---|---|---|---|---|
| | | | Yes | Surface Condition? (G/P) | Good |
