Access Compliance Report Public Rights-of-Way (Curb Ramps)

Intersection ID: 47452 Main Street: WHISTLING SWAN RD **Cross Street: MALLARD LANDING RD** Location: SE **ADA ID: 8A8D78EFC517** Ramp Type: PerpDiag Initial Pass/Fail: Fail **Overall Compliance: No Severity Score:** 25

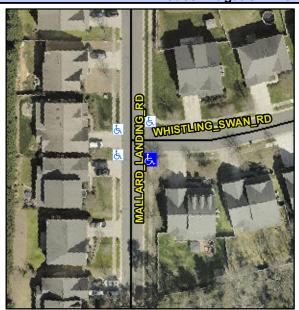
Field Measurements/Component Compliance							
C	Compliance Description		Data	Comp	oliance	Description	Data
N/	A Ramp I	Length (in)	46.0	No	Ram	Slope (%)	8.5
Υe	s Ramp	Width (in)	48.0	No	Ram	XSlope (%)	5.4
N/	A Flare T	ype LT	N/A	N/A	Flare	Type RT	N/A
N/	A Flare S	Slope LT (%)	N/A	N/A	Flare	Slope RT (%)	N/A
N/	A Flare T	raversable LT?	N/A	N/A	Flare	Traversable RT?	N/A
N/	A Landing	g Length (in)	N/A	N/A	DWS	Provided?	N/A
N/	A Landing	g Width (in)	N/A	N/A	DWS	Contrast?	N/A
N/	A Landing	g Slope (%)	N/A	N/A	DWS	Length (in)	N/A
N/	A Landin	g X Slope (%)	N/A	N/A	DWS	Full Width?	N/A
N/	A Landing	g Curb? (Y/N)	N/A	N/A	DWS	Offset (in)	N/A
N/	A Shared	Landing?	N/A				
N/	A Gutter	Ponding?	N/A	N/A	Gutte	er Slope (%)	N/A
N/	A Gutter	Lip Ht (in)	N/A	N/A	Gutte	er X Slope (%)	N/A
N/	A Painted	d X Walk1?	No	N/A	Paint	ed X Walk2?	No
	X Walk	1 Direction	To NE		X Wa	lk 2 Direction	To NW
N/	A X Walk	1 Width (in)	N/A	N/A	X Wa	lk 2 Width (in)	N/A

X Walk	1 Slope (%)	0.0		X Wa	lk 2 Slope (%)	3.9
	X Walk	1 X Slope (%)	5.5		X Wa	lk 2 X Slope (%)	2.5
N/	A Ramp i	nside XWalk1?	N/A	N/A	Ram	o inside XWalk2?	N/A
	Road S	Slope (%)	5.1	N/A	Clear	Space?	N/A
	Road X	(Slope (%)	3.1	N/A	Clear	Space to XWalk (in)	N/A
N/	A Any Ob	ostructions?	N/A	N/A	Storn	n Grate/Utility Hazard?	N/A
	Obstru	ction Type			Storn	n Grate/Utility Type	
			N/A				N/A
				Yes	Surfa	ce Condition? (G/P)	Good

Possible Solutions: Remove & Replace Curb Ramp With Two New Directional Ramps or Equivalent. Surveyor Notes: N/A PROW/ADA: Not Found, R304.2.2, R304.5.3
