Access Compliance Report

Public Rights-of-Way

(Curb Ramps)

Intersection ID: 30307	Main Street: BLACK_KETTLE_DR	Cross Street: FLYING_SCOTSMAN_DR	Location: SE
ADA ID: 8A9413ACA6DD	Ramp Type: PerpDiag	Initial Pass/Fail: Fail	Overall Compliance: No
Severity Score: 10			
Codes/Mitigation Info/Possible Solution		Field Measurements/Component Compliance

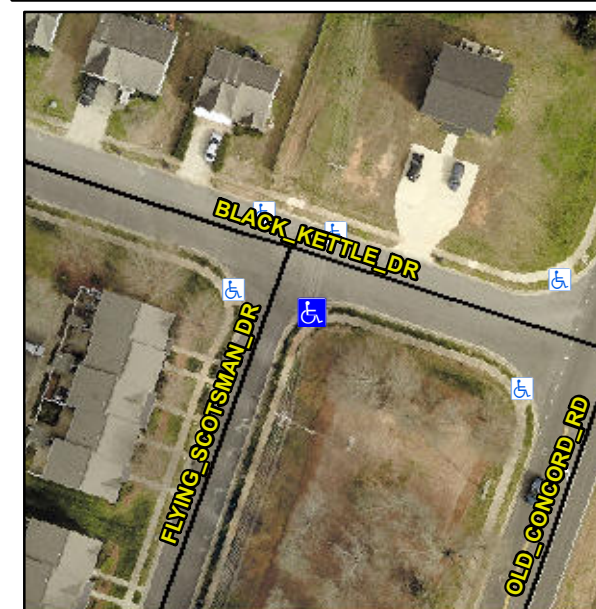
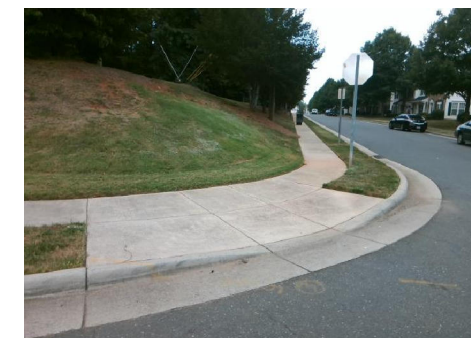
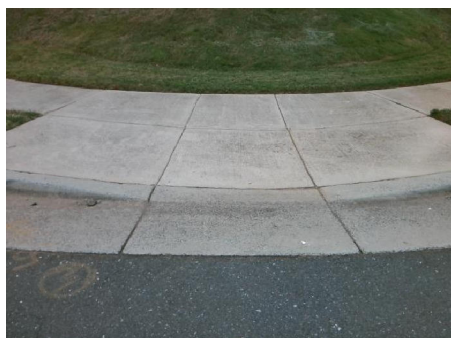
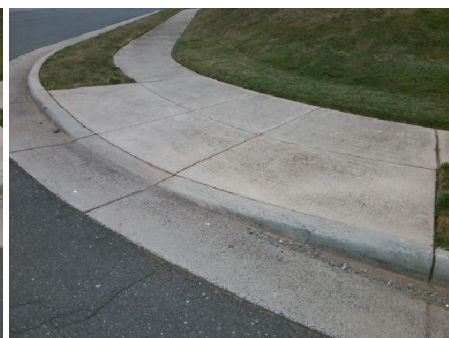
Not Found, R304.5.1, R304.5.3

Compliance	Description	Data	Compliance	Description	Data
N/A	Ramp Length (in)	46.0	Yes	Ramp Slope (%)	6.7
No	Ramp Width (in)	42.0	No	Ramp XSlope (%)	2.2
N/A	Flare Type LT	N/A	N/A	Flare Type RT	N/A
N/A	Flare Slope LT (%)	N/A	N/A	Flare Slope RT (%)	N/A
N/A	Flare Traversable LT?	N/A	N/A	Flare Traversable RT?	N/A
N/A	Landing Length (in)	N/A	N/A	DWS Provided?	N/A
N/A	Landing Width (in)	N/A	N/A	DWS Contrast?	N/A
N/A	Landing Slope (%)	N/A	N/A	DWS Length (in)	N/A
N/A	Landing X Slope (%)	N/A	N/A	DWS Full Width?	N/A
N/A	Landing Curb? (Y/N)	N/A	N/A	DWS Offset (in)	N/A
N/A	Shared Landing?	N/A			
N/A	Gutter Ponding?	N/A	N/A	Gutter Slope (%)	N/A
N/A	Gutter Lip Ht (in)	N/A	N/A	Gutter X Slope (%)	N/A
N/A	Painted X Walk1?	No	N/A	Painted X Walk2?	No
	X Walk 1 Direction	To N		X Walk 2 Direction	To NW
N/A	X Walk 1 Width (in)	N/A	N/A	X Walk 2 Width (in)	N/A
	X Walk 1 Slope (%)	3.8		X Walk 2 Slope (%)	4.2
	X Walk 1 X Slope (%)	3.3		X Walk 2 X Slope (%)	4.2

N/A	Ramp inside XWalk1?	N/A	N/A	Ramp inside XWalk2?	N/A
	Road Slope (%)	1.6	N/A	Clear Space?	N/A
	Road X Slope (%)	4.6	N/A	Clear Space to XWalk (in)	N/A
N/A	Any Obstructions?	N/A	N/A	Storm Grate/Utility Hazard?	N/A
	Obstruction Type			Storm Grate/Utility Type	
		N/A			N/A
		Yes		Surface Condition? (G/P)	Good

Remove & Replace Curb Ramp With Two New Directional Ramps or Equivalent.

Total Cost: \$ 3200.00
