Access Compliance Report Public Rights-of-Way (Curb Ramps)

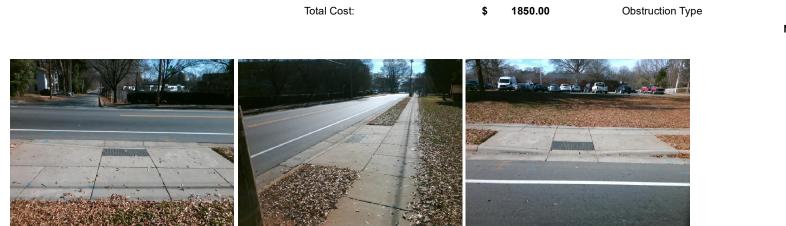
Interrection ID: 8067	terestian ID: 9067 Main Street: BRADEORD DD				Cross Street: LYNN_ST				C/M
Intersection ID: 8967	7 Main Street: BRADFORD_DR			Street:	LTNN_51			Location:	SW
ADA ID: 8A956AD53F95 Ramp Type: Perp			Initial	Initial Pass/Fail: Fail Overall Compliance: No				o Severity Score:	27.5
Codes/Mitigation Info/Possible Solution				Field Measurements/Component Compliance					
	1 and 1 and	Possible Solutions:		Compliance Description			Data Compliance Description		Data
		Remove & Replace Entire Ran	ıp.	N/A	Ramp Length (in)	53.0	No	Ramp Slope (%)	9.0
	and the second		•	Yes	Ramp Width (in)	48.0	Yes	Ramp XSlope (%)	1.1

No Surface Condition? (G/P)

Poor

11. 2.	PROW/ADA:		N/A	Gutter Ponding?	N/A	N/A	Gutter Slope (%)	N/A
	A L	Not Found, R304.2.2, R302.7		N/A	Gutter Lip Ht (in)	N/A	N/A	Gutter X Slope (%)	N/A
	1	,,,,		N/A	Painted X Walk1?	No	N/A	Painted X Walk2?	N/A
	w.70				X Walk 1 Direction	To E		X Walk 2 Direction	N/A
				N/A	X Walk 1 Width (in)	N/A	N/A	X Walk 2 Width (in)	N/A
Street 1 Name	BRADFORD DR	-			X Walk 1 Slope (%)	3.1		X Walk 2 Slope (%)	N/A
Stop Condition-Street 2	None				X Walk 1 X Slope (%)	1.0		X Walk 2 X Slope (%)	N/A
Street 2 Name	N/A			N/A	Ramp inside XWalk1?	N/A	N/A	Ramp inside XWalk2?	N/A
Stop Condition-Street 1	N/A				Road Slope (%)	N/A	N/A	Clear Space?	N/A
					Road X Slope (%)	N/A	N/A	Clear Space to XWalk (in)	N/A
				N/A	Any Obstructions?	N/A	N/A	Storm Grate/Utility Hazard?	N/A
		Total Cost: \$	1850.00		Obstruction Type			Storm Grate/Utility Type	
						N/A			N/A
