## **Access Compliance Report Public Rights-of-Way** (Curb Ramps)

Intersection ID: N/A Main Street: BROOKSVALE\_ST Cross Street: N/A Location: SW **Overall Compliance: No** ADA ID: 8A99A54FC242 Ramp Type: Perp Initial Pass/Fail: Fail Severity Score: 13.75

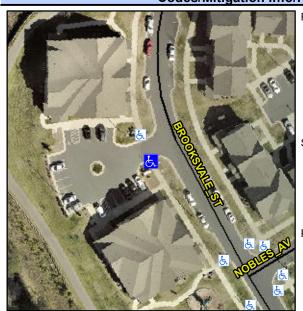
Field Measurements/Component Compliance								
Compl	iance Description	Data	Compl	iance	Description	Data		
N/A	Ramp Length (in)	72.0	No	Ramp	Slope (%)	8.9		
Yes	Ramp Width (in)	70.0	No	No Ramp XSlope (%)		2.2		
N/A	Flare Type LT	N/A	N/A	A Flare Type RT		N/A		
N/A	Flare Slope LT (%)	N/A	N/A	A Flare Slope RT (%)		N/A		
N/A	Flare Traversable LT?	N/A	N/A	Flare	Traversable RT?	N/A		
N/A	Landing Length (in)	N/A	N/A	DWS	Provided?	N/A		
N/A	Landing Width (in)	N/A	N/A	DWS	Contrast?	N/A		
N/A	Landing Slope (%)	N/A	N/A	DWS	Length (in)	N/A		
N/A	Landing X Slope (%)	N/A	N/A	DWS	Full Width?	N/A		
N/A	Landing Curb? (Y/N)	N/A	N/A	DWS	Offset (in)	N/A		
N/A	Shared Landing?	N/A						
N/A	Gutter Ponding?	N/A	N/A	Gutte	r Slope (%)	N/A		
N/A	Gutter Lip Ht (in)	N/A	N/A	Gutte	r X Slope (%)	N/A		
N/A	Painted X Walk1?	No	N/A	Paint	ed X Walk2?	N/A		
	X Walk 1 Direction	To N		X Wa	lk 2 Direction	N/A		
N/A	X Walk 1 Width (in)	N/A	N/A	X Wa	lk 2 Width (in)	N/A

X Walk 1 Slope (%)	3.3		X Wa	lk 2 Slope (%)	N/A		
	X Walk 1 X Slope (%)	1.0		X Wa	lk 2 X Slope (%)	N/A		
N/A	Ramp inside XWalk1?	N/A	N/A	Ramp	inside XWalk2?	N/A		
	Road Slope (%)	N/A	N/A	Clear	Space?	N/A		
	Road X Slope (%)	N/A	N/A	Clear	Space to XWalk (in)	N/A		
N/A	Any Obstructions?	N/A	N/A	Storn	n Grate/Utility Hazard?	N/A		
	Obstruction Type			Storn	n Grate/Utility Type			
		N/A				N/A		
			Yes	Surfa	ce Condition? (G/P)	Good

USSIDIE SUIULIUII	
ossible Solutions:	Co
Remove & Replace Entire Ramp.	N/A
·	Yes
	N/A
	N/A
	N/A
	N/A
surveyor Notes:	N/A
N/A	N/A
	N/A
	N/A
	N/A
ROW/ADA:	N/A
R304.2.2, R304.5.3	N/A
	N/A
	N/A
	N/A
