# Access Compliance Report

## Public Rights-of-Way

| Intersection ID: 42366 | Main Street: CARDINALS_NEST_DR | Cross Street: HERON_GLEN_DR | Location: | N |
| ADA ID: 8AA21883FA4A | Ramp Type: PerpDiag | Initial Pass/Fail: Pass | Overall Compliance: No | Severity Score: 25 |

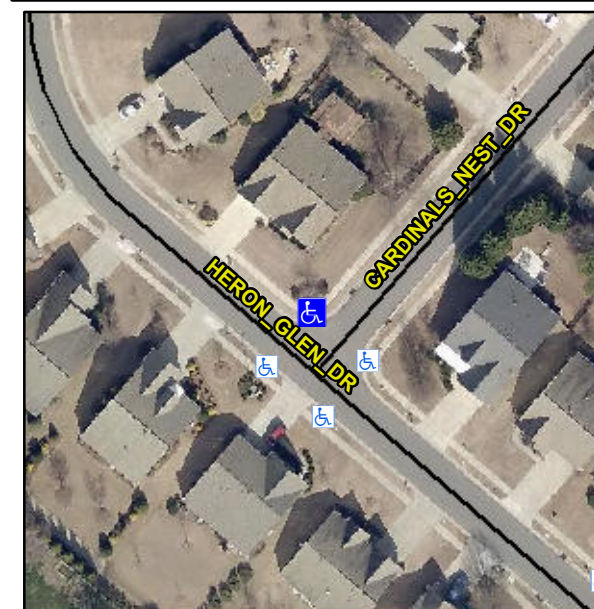
| Compliance | Description | Data | Compliance | Description | Data |
|---|---|---|---|---|---|
| Yes | Landing Length (in) | 49.0 | No | DWS Provided? | No |
| No | Landing Slope (%) | 4.9 | N/A | DWS Length (in) | N/A |
| No | Gutter Lip Ht (in) | 1.5 | Yes | Gutter X Slope (%) | 0.1 |

**Remove & Replace Curb Ramp With Two New Directional Ramps or Equivalent. Grind Gutter Lip.**

**R304.2.2-Perp, R304.3.2-Para, R305, R302.7.2**

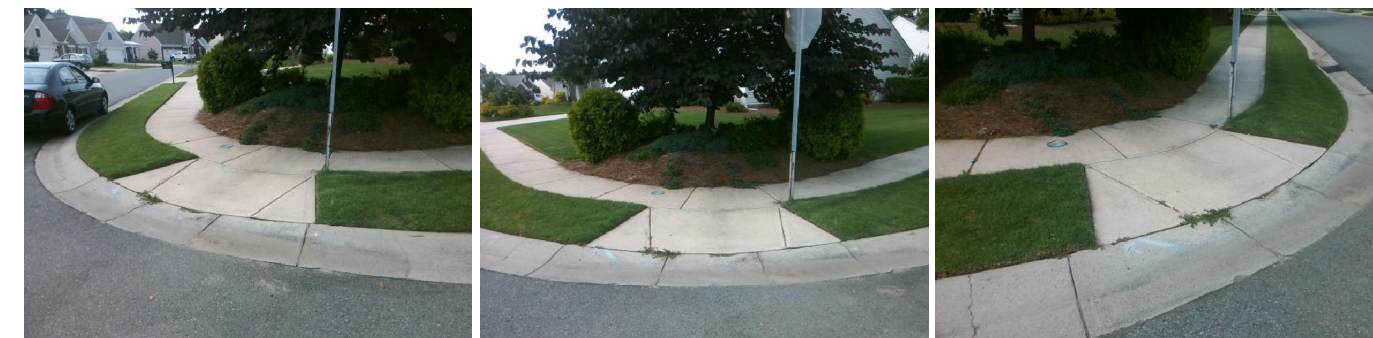
Street 1 Name **HERO GLEN DR**  
 Stop Condition-Street 2 **None**  
 Street 2 Name **CARDINALS NEST DR**  
 Stop Condition-Street 1 **StopSign**
