Access Compliance Report

Public Rights-of-Way (Curb Ramps)

Intersection ID: 5525	Main Street: W_W_T_HARRIS_BV	Cross Street: MCCULLOUGH_DR	Location: S
ADA ID: 8AB0017A373F	Ramp Type: Combination2	Initial Pass/Fail: Fail	Overall Compliance: No
Codes/Mitigation Info/Possible Solution		Field Measurements/Component Compliance	
Severity Score: 25

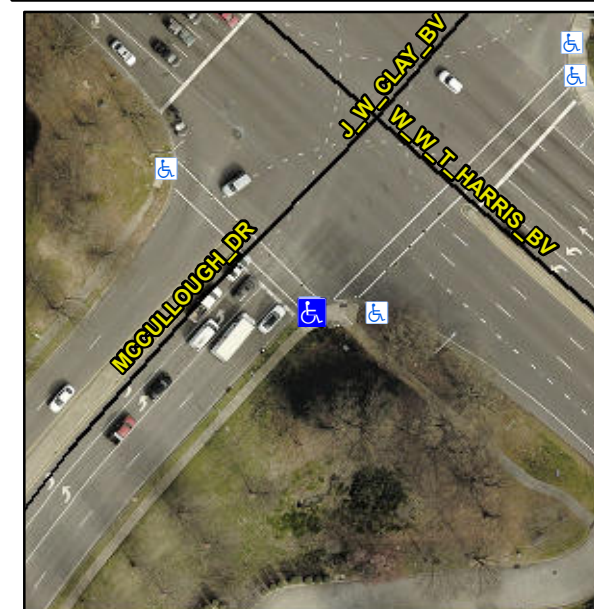
Compliance	Description	Data	Compliance	Description	Data
N/A	Ramp Length LT (in)	N/A	N/A	Ramp Length RT (in)	62.0
N/A	Ramp Width LT (in)	N/A	Yes	Ramp Width RT (in)	48.0
N/A	Ramp Slope LT (%)	N/A	Yes	Ramp Slope RT (%)	5.2
N/A	Ramp XSlope LT (%)	N/A	Yes	Ramp XSlope RT (%)	1.1
N/A	Ramp Length (in)	60.0	No	Ramp Slope (%)	18.2
Yes	Ramp Width (in)	48.0	Yes	Ramp XSlope (%)	1.9
N/A	Flare Type LT	N/A	N/A	Flare Type RT	N/A
N/A	Flare Slope LT (%)	N/A	N/A	Flare Slope RT (%)	N/A
N/A	Flare Traversable LT?	N/A	N/A	Flare Traversable RT?	N/A
N/A	Landing Length (in)	N/A	N/A	DWS Provided?	N/A
N/A	Landing Width (in)	N/A	N/A	DWS Contrast?	N/A
N/A	Landing Slope (%)	N/A	N/A	DWS Length (in)	N/A
N/A	Landing X Slope (%)	N/A	N/A	DWS Full Width?	N/A
N/A	Landing Curb? (Y/N)	N/A	N/A	DWS Offset (in)	N/A
N/A	Shared Landing?	N/A			
N/A	Gutter Ponding?	N/A	N/A	Gutter Slope (%)	N/A
N/A	Gutter Lip Ht (in)	N/A	N/A	Gutter X Slope (%)	N/A
N/A	Painted X Walk1?	No	N/A	Painted X Walk2?	N/A

X Walk 1 Direction	To NW		X Walk 2 Direction	N/A
	X Walk 1 Width (in)	N/A		X Walk 2 Width (in)	N/A
	X Walk 1 Slope (%)	2.6		X Walk 2 Slope (%)	N/A
	X Walk 1 X Slope (%)	3.5		X Walk 2 X Slope (%)	N/A
N/A	Ramp inside XWalk1?	N/A	N/A	Ramp inside XWalk2?	N/A
	Road Slope (%)	N/A		Clear Space?	N/A
	Road X Slope (%)	N/A	N/A	Clear Space to XWalk (in)	N/A
			N/A	Any Obstruction?	N/A
				Obstruction Type	N/A
			N/A	Storm Grate/Utility Hazard?	N/A
				Storm Grate/Utility Type	N/A
			Yes	Surface Condition? (G/P)	Good
				Curb Slope (%)	N/A

Remove & Replace Entire Ramp.

R304.2.2

\$ 1600.00
