## Access Compliance Report Public Rights-of-Way (Curb Ramps)

Intersection ID: 5672 Main Street: SUNSET\_RD Cross Street: BEATTIES\_FORD\_RD Location: SE

ADA ID: 8AC976385F72 Ramp Type: Perp Initial Pass/Fail: Fail Overall Compliance: No Severity Score: 21.25

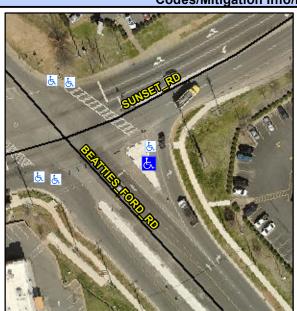
Not Found, R304.5.1, R304.2.2

N/A	Ramp Length (in)	60.0	No	Ramp Slope (%)	8.5
No	Ramp Width (in)	47.0	Yes	Ramp XSlope (%)	1.7
N/A	Flare Type LT	N/A	N/A	Flare Type RT	N/A
N/A	Flare Slope LT (%)	N/A	N/A	Flare Slope RT (%)	N/A
N/A	Flare Traversable LT?	N/A	N/A	Flare Traversable RT?	N/A
N/A	Landing Length (in)	N/A	N/A	DWS Provided?	N/A
N/A	Landing Width (in)	N/A	N/A	DWS Contrast?	N/A
N/A	Landing Slope (%)	N/A	N/A	DWS Length (in)	N/A
N/A	Landing X Slope (%)	N/A	N/A	DWS Full Width?	N/A
N/A	Landing Curb? (Y/N)	N/A	N/A	DWS Offset (in)	N/A
N/A	Shared Landing?	N/A			
N/A	Gutter Ponding?	N/A	N/A	Gutter Slope (%)	N/A
N/A	Gutter Lip Ht (in)	N/A	N/A	Gutter X Slope (%)	N/A
N/A	Painted X Walk1?	Yes	N/A	Painted X Walk2?	N/A
	X Walk 1 Direction	To W		X Walk 2 Direction	N/A
N/A	X Walk 1 Width (in)	92.0	N/A	X Walk 2 Width (in)	N/A
	X Walk 1 Slope (%)	3.3		X Walk 2 Slope (%)	N/A
	X Walk 1 X Slope (%)	1.8		X Walk 2 X Slope (%)	N/A
N/A	Ramp inside XWalk1?	Yes	N/A	Ramp inside XWalk2?	N/A

Possible Solutions:

Remove & Replace Entire Ramp.

Total Cost: \$ 1850.00
