# Access Compliance Report

## Public Rights-of-Way

| Intersection ID: 15786 | Main Street: N_SHARON_AMITY_RD | Cross Street: AMITY_PL | Location: S |
| ADA ID: 8AD49FBAEBB0 | Ramp Type: BlendTrans1 | Initial Pass/Fail: Pass | Overall Compliance: No |

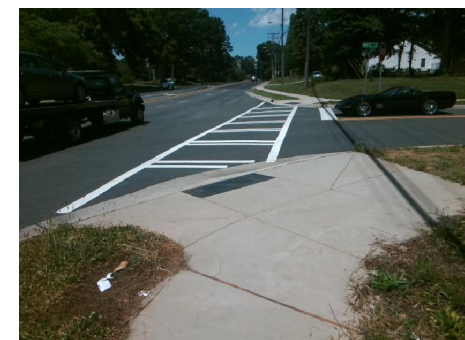
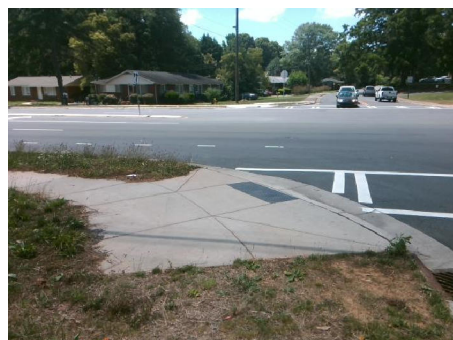
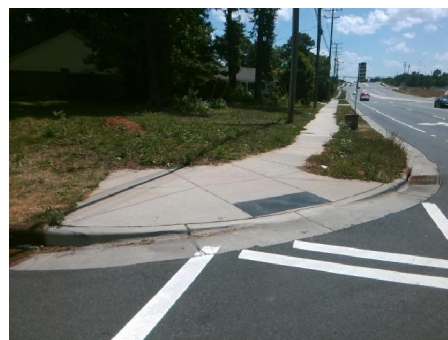
**DWS WARPED**

| Compliance | Description | Data | Compliance | Description | Data |
|---|---|---|---|---|---|
| Yes | Ramp Width (in) | 59.0 | No | BlendTrans XSlope (%) | 2.4 |
| N/A | Landing Curb? (Y/N) | No | No | DWS Offset (in) | 2.5 |
| Yes | Gutter Lip Ht (in) | 0.0 | No | Gutter X Slope (%) | 2.4 |

**Remove & Replace Curb Ramp With Two New Directional Ramps or Equivalent. Remove & Replace Gutter.**

**R304.5.3, R305.2**
