Access Compliance Report

Public Rights-of-Way

(Curb Ramps)

Intersection ID: 10026441	Main Street: FARMHURST_DR	Cross Street: N/A	Location: NE
ADA ID: 8ADD80A8D3EE	Ramp Type: BlendTrans2	Initial Pass/Fail: Fail	Overall Compliance: No
		Severity Score: 25

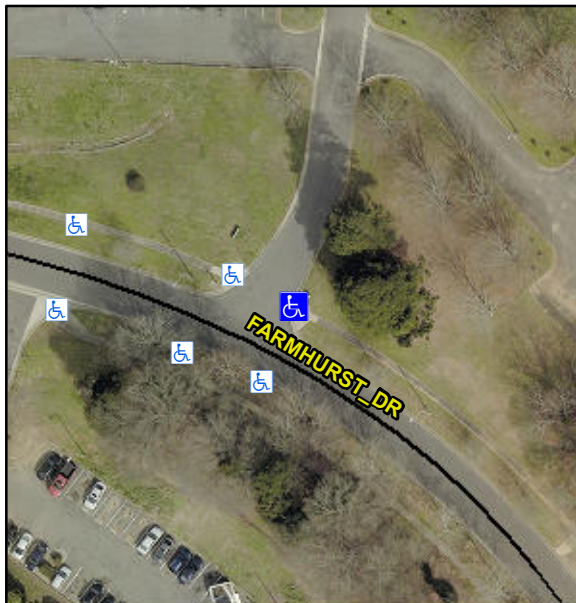
Not Found, R304.5.3

Compliance	Description	Data	Compliance	Description	Data
N/A	Ramp Length (in)	92.0	Yes	BlendTrans Slope (%)	0.8
Yes	Ramp Width (in)	50.0	No	BlendTrans XSlope (%)	8.1
N/A	Flare Type LT	N/A	N/A	Flare Type RT	N/A
N/A	Flare Slope LT (%)	N/A	N/A	Flare Slope RT (%)	N/A
N/A	Flare Traversable LT?	N/A	N/A	Flare Traversable RT?	N/A
N/A	Landing Length (in)	N/A	N/A	DWS Provided?	N/A
N/A	Landing Width (in)	N/A	N/A	DWS Contrast?	N/A
N/A	Landing Slope (%)	N/A	N/A	DWS Length (in)	N/A
N/A	Landing X Slope (%)	N/A	N/A	DWS Full Width?	N/A
N/A	Landing Curb? (Y/N)	N/A	N/A	DWS Offset (in)	N/A
N/A	Shared Landing?	N/A			
N/A	Gutter Ponding?	N/A	N/A	Gutter Slope (%)	N/A
N/A	Gutter Lip Ht (in)	N/A	N/A	Gutter X Slope (%)	N/A
N/A	Painted X Walk1?	No	N/A	Painted X Walk2?	No
	X Walk 1 Direction	To NW		X Walk 2 Direction	To SW
	X Walk 1 Width (in)	N/A		X Walk 2 Width (in)	N/A
	X Walk 1 Slope (%)	1.8		X Walk 2 Slope (%)	7.0
	X Walk 1 X Slope (%)	8.1		X Walk 2 X Slope (%)	3.7

N/A	Ramp inside XWalk1?	N/A	N/A	Ramp inside XWalk2?	N/A
	Road Slope (%)	8.5		Clear Space?	N/A
	Road X Slope (%)	0.4	N/A	Clear Space to XWalk (in)	N/A
N/A	Any Obstructions?	N/A	N/A	Storm Grate/Utility Hazard?	N/A
	Obstruction Type			Storm Grate/Utility Type	
		N/A			N/A
			Yes	Surface Condition? (G/P)	Good
			No	Curb Slope (%)	16.3

Remove & Replace Curb Ramp With Two New Directional Ramps or Equivalent.
