# Access Compliance Report

## Public Rights-of-Way

### (Curb Ramps)

Intersection ID: 50596	Main Street: STREAM_ORCHID_LN	Cross Street: GRAY_WILLOW_RD	Location: SE
ADA ID: 8AEB350BBACD	Ramp Type: Perp	Initial Pass/Fail: Fail	Overall Compliance: No
Severity Score: 22.5			
Codes/Mitigation Info/Possible Solution		Field Measurements/Component Compliance

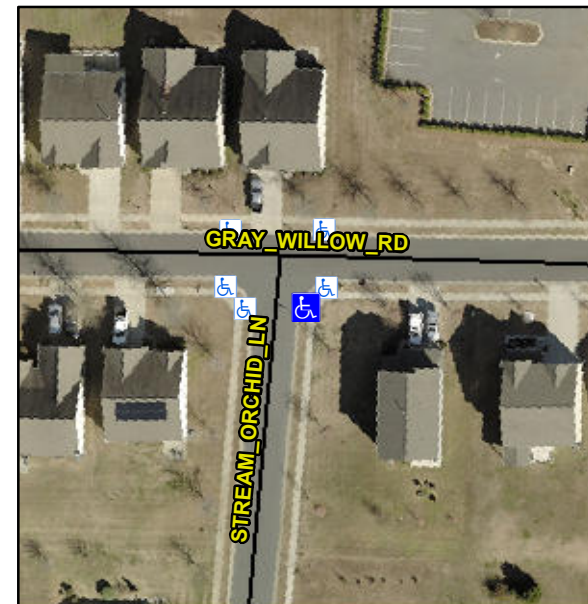
**Not Found, R304.5.1, R304.2.2, R304.5.3**

Compliance	Description	Data	Compliance	Description	Data
N/A	Ramp Length (in)	49.0	No	Ramp Slope (%)	9.6
No	Ramp Width (in)	47.5	No	Ramp XSlope (%)	2.8
N/A	Flare Type LT	N/A	N/A	Flare Type RT	N/A
N/A	Flare Slope LT (%)	N/A	N/A	Flare Slope RT (%)	N/A
N/A	Flare Traversable LT?	N/A	N/A	Flare Traversable RT?	N/A
N/A	Landing Length (in)	N/A	N/A	DWS Provided?	N/A
N/A	Landing Width (in)	N/A	N/A	DWS Contrast?	N/A
N/A	Landing Slope (%)	N/A	N/A	DWS Length (in)	N/A
N/A	Landing X Slope (%)	N/A	N/A	DWS Full Width?	N/A
N/A	Landing Curb? (Y/N)	N/A	N/A	DWS Offset (in)	N/A
N/A	Shared Landing?	N/A			
N/A	Gutter Ponding?	N/A	N/A	Gutter Slope (%)	N/A
N/A	Gutter Lip Ht (in)	N/A	N/A	Gutter X Slope (%)	N/A
N/A	Painted X Walk1?	No	N/A	Painted X Walk2?	N/A
	X Walk 1 Direction	To W		X Walk 2 Direction	N/A
N/A	X Walk 1 Width (in)	N/A	N/A	X Walk 2 Width (in)	N/A
	X Walk 1 Slope (%)	1.4		X Walk 2 Slope (%)	N/A
	X Walk 1 X Slope (%)	2.6		X Walk 2 X Slope (%)	N/A

Possible Solutions:

**Remove & Replace Entire Ramp.**

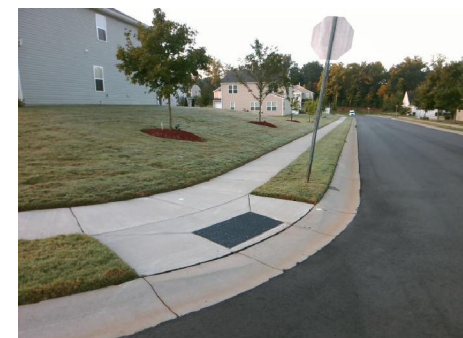
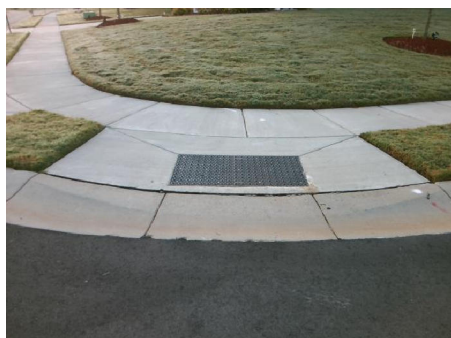
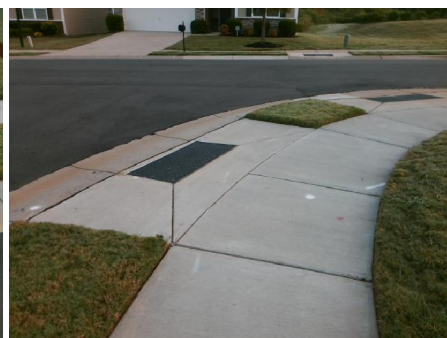
N/A	Ramp inside XWalk1?	N/A	N/A	Ramp inside XWalk2?	N/A
	Road Slope (%)	N/A	N/A	Clear Space?	N/A
	Road X Slope (%)	N/A	N/A	Clear Space to XWalk (in)	N/A
N/A	Any Obstructions?	N/A	N/A	Storm Grate/Utility Hazard?	N/A
	Obstruction Type			Storm Grate/Utility Type	
		N/A			N/A
			Yes	Surface Condition? (G/P)	Good
