# Access Compliance Report

## Public Rights-of-Way (Curb Ramps)

Intersection ID: 51509	Main Street: EASTFIELD_PARK_DR	Cross Street: NETHERTON_LN	Location:	N
ADA ID: 8AF901C04A2D	Ramp Type: PerpDiag	Initial Pass/Fail: Fail	Overall Compliance: No	Severity Score: 10

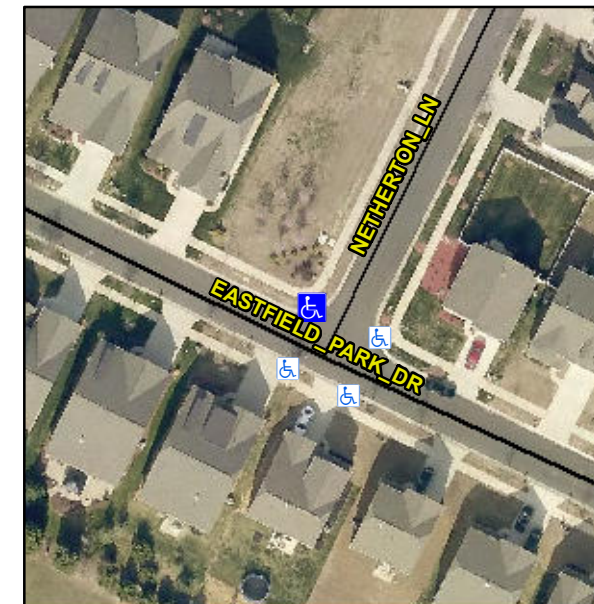
**Not Found, R304.5.1, R304.5.3**

Compliance	Description	Data	Compliance	Description	Data
N/A	Ramp Length (in)	71.0	Yes	Ramp Slope (%)	6.7
No	Ramp Width (in)	47.5	No	Ramp XSlope (%)	4.2
N/A	Flare Type LT	N/A	N/A	Flare Type RT	N/A
N/A	Flare Slope LT (%)	N/A	N/A	Flare Slope RT (%)	N/A
N/A	Flare Traversable LT?	N/A	N/A	Flare Traversable RT?	N/A
N/A	Landing Length (in)	N/A	N/A	DWS Provided?	N/A
N/A	Landing Width (in)	N/A	N/A	DWS Contrast?	N/A
N/A	Landing Slope (%)	N/A	N/A	DWS Length (in)	N/A
N/A	Landing X Slope (%)	N/A	N/A	DWS Full Width?	N/A
N/A	Landing Curb? (Y/N)	N/A	N/A	DWS Offset (in)	N/A
N/A	Shared Landing?	N/A			
N/A	Gutter Ponding?	N/A	N/A	Gutter Slope (%)	N/A
N/A	Gutter Lip Ht (in)	N/A	N/A	Gutter X Slope (%)	N/A
N/A	Painted X Walk1?	No	N/A	Painted X Walk2?	No
	X Walk 1 Direction	To SW		X Walk 2 Direction	To SE
N/A	X Walk 1 Width (in)	N/A	N/A	X Walk 2 Width (in)	N/A
	X Walk 1 Slope (%)	4.7		X Walk 2 Slope (%)	3.5
	X Walk 1 X Slope (%)	0.8		X Walk 2 X Slope (%)	4.7

N/A	Ramp inside XWalk1?	N/A	N/A	Ramp inside XWalk2?	N/A
	Road Slope (%)	4.7	N/A	Clear Space?	N/A
	Road X Slope (%)	5.0	N/A	Clear Space to XWalk (in)	N/A
N/A	Any Obstructions?	N/A	N/A	Storm Grate/Utility Hazard?	N/A
	Obstruction Type			Storm Grate/Utility Type	
		N/A			N/A
			Yes	Surface Condition? (G/P)	Good

**Remove & Replace Curb Ramp With Two New Directional Ramps or Equivalent.**
