Access Compliance Report Public Rights-of-Way (Curb Ramps)

Intersection ID: 12499	Main Street: PRUITT_ST			Cross Street: WILKINSON_BV					Location:	NE
ADA ID: 8B0A88B34B43	8 Ramp Type: Perp			Initial Pass/Fail: Fail Overall Compliance: No					o Severity Score:	22.5
Codes/Mitigation Info/Possible Solution				Field Measurements/Component Compliance						
	}	Possible Solutions:		Compliance Description			Data	Data Compliance Description		
A CONTRACT OF A	The second se	Remove & Replace Entire	e Ramp.	N/	A	Ramp Length (in)	41.0	No	Ramp Slope (%)	8.8

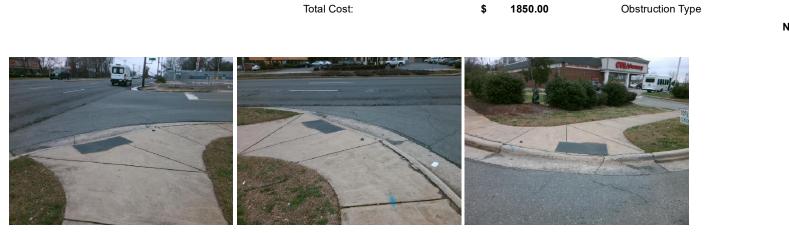
1.	•	•	No	5	Ramp Width (in)	36.0	No	Ramp XSlope (%)	2.8
				N//	Α	Flare Type LT	N/A	N/A	Flare Type RT	N/A
	A MARTINE			N//	Α	Flare Slope LT (%)	N/A	N/A	Flare Slope RT (%)	N/A
	~			N//	Α	Flare Traversable LT?	N/A	N/A	Flare Traversable RT?	N/A
	A Dim. Co.			N//	A	Landing Length (in)	N/A	N/A	DWS Provided?	N/A
	Manual Ali at	Surveyor Notes:		N/2	Α	Landing Width (in)	N/A	N/A	DWS Contrast?	N/A

- CO	N/A		N//	A	Landing Slope (%)	N/A	N/A	DWS Length (in)	N/A
				N//	Α	Landing X Slope (%)	N/A	N/A	DWS Full Width?	N/A
WILKINSON BV			N//	A	Landing Curb? (Y/N)	N/A	N/A	DWS Offset (in)	N/A	
all a				N//	A	Shared Landing?	N/A			
	i fan fan	PROW/ADA:		N//	A	Gutter Ponding?	N/A	N/A	Gutter Slope (%)	N/A
	F	Not Found, R304.5.1, R3	04.2.2,	N//	Α	Gutter Lip Ht (in)	N/A	N/A	Gutter X Slope (%)	N/A
A A	R304.5.3		N/2	A	Painted X Walk1?	No	N/A	Painted X Walk2?	N/A	
					X Walk 1 Direction	To W		X Walk 2 Direction	N/A	
				N//	A	X Walk 1 Width (in)	N/A	N/A	X Walk 2 Width (in)	N/A
Street 1 Name	PRUITT ST					X Walk 1 Slope (%)	3.4		X Walk 2 Slope (%)	N/A
Stop Condition-Street 2	StopSign					X Walk 1 X Slope (%)	0.4		X Walk 2 X Slope (%)	N/A
Street 2 Name	N/A			N//	A	Ramp inside XWalk1?	N/A	N/A	Ramp inside XWalk2?	N/A
Stop Condition-Street 1	N/A					Road Slope (%)	N/A	N/A	Clear Space?	N/A
						Road X Slope (%)	N/A	N/A	Clear Space to XWalk (in)	N/A
