Access Compliance Report

Public Rights-of-Way

(Curb Ramps)

| Intersection ID: 6956 | Main Street: PLUMSTEAD_RD | Cross Street: MCALLISTER_DR | Location: | N |

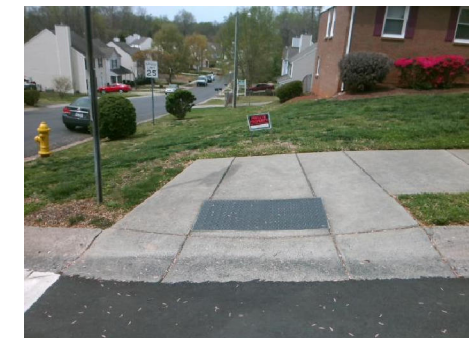
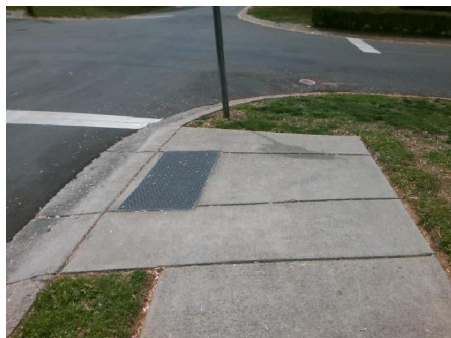
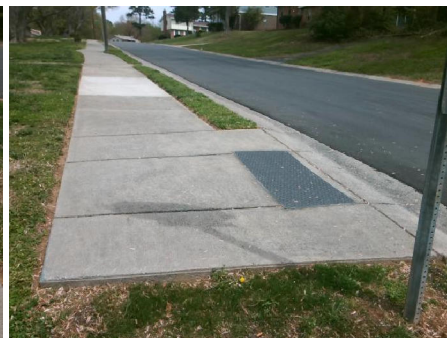
| ADA ID: 8B14BB257128 | Ramp Type: Combination1 | Initial Pass/Fail: Fail | Overall Compliance: No | Severity Score: 25 |

RP < 5%

Not Found, R304.5.1, R304.5.3

| Compliance | Description | Data | Compliance | Description | Data |
|---|---|---|---|---|---|
| No | Ramp Width (in) | 34.0 | No | Ramp XSlope (%) | 14.7 |

Remove & Replace Entire Ramp.

Total Cost: \$ 1800.00
