Access Compliance Report

Public Rights-of-Way

(Curb Ramps)

Intersection ID: 4938	Main Street: BAUCOM_RD	Cross Street: CARMATHEN_RD	Location:	N
ADA ID: 8B183A5795D8	Ramp Type: Perp	Initial Pass/Fail: Fail	Overall Compliance: No	Severity Score: 8.75
Codes/Mitigation Info/Possible Solution		Field Measurements/Component Compliance

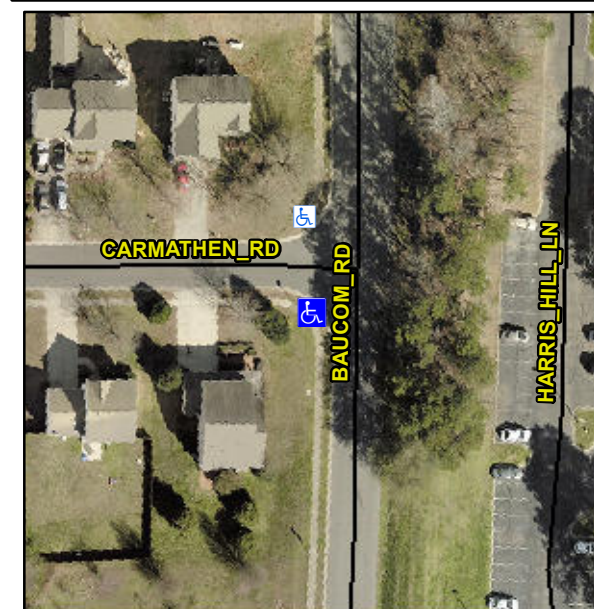
Not Found, R304.5.1

Compliance	Description	Data	Compliance	Description	Data
N/A	Ramp Length (in)	48.0	Yes	Ramp Slope (%)	7.5
No	Ramp Width (in)	39.0	Yes	Ramp XSlope (%)	1.8
N/A	Flare Type LT	N/A	N/A	Flare Type RT	N/A
N/A	Flare Slope LT (%)	N/A	N/A	Flare Slope RT (%)	N/A
N/A	Flare Traversable LT?	N/A	N/A	Flare Traversable RT?	N/A
N/A	Landing Length (in)	N/A	N/A	DWS Provided?	N/A
N/A	Landing Width (in)	N/A	N/A	DWS Contrast?	N/A
N/A	Landing Slope (%)	N/A	N/A	DWS Length (in)	N/A
N/A	Landing X Slope (%)	N/A	N/A	DWS Full Width?	N/A
N/A	Landing Curb? (Y/N)	N/A	N/A	DWS Offset (in)	N/A
N/A	Shared Landing?	N/A			
N/A	Gutter Ponding?	N/A	N/A	Gutter Slope (%)	N/A
N/A	Gutter Lip Ht (in)	N/A	N/A	Gutter X Slope (%)	N/A
N/A	Painted X Walk1?	No	N/A	Painted X Walk2?	N/A
	X Walk 1 Direction	To SW		X Walk 2 Direction	N/A
N/A	X Walk 1 Width (in)	N/A	N/A	X Walk 2 Width (in)	N/A
	X Walk 1 Slope (%)	0.6		X Walk 2 Slope (%)	N/A
	X Walk 1 X Slope (%)	1.7		X Walk 2 X Slope (%)	N/A

N/A	Ramp inside XWalk1?	N/A	N/A	Ramp inside XWalk2?	N/A
	Road Slope (%)	N/A	N/A	Clear Space?	N/A
	Road X Slope (%)	N/A	N/A	Clear Space to XWalk (in)	N/A
N/A	Any Obstructions?	N/A	N/A	Storm Grate/Utility Hazard?	N/A
	Obstruction Type			Storm Grate/Utility Type	
		N/A			N/A
			Yes	Surface Condition? (G/P)	Good

Possible Solutions:

Remove & Replace Entire Ramp.

Total Cost: \$ 1850.00
