Access Compliance Report

Public Rights-of-Way

(Curb Ramps)

Intersection ID: 10019500	Main Street: ALICE_MCGINN_DR	Cross Street: N/A	Location: NE
ADA ID: 8B20524C4F25	Ramp Type: Perp	Initial Pass/Fail: Fail	Overall Compliance: No
Severity Score: 13.75			
Codes/Mitigation Info/Possible Solution		Field Measurements/Component Compliance

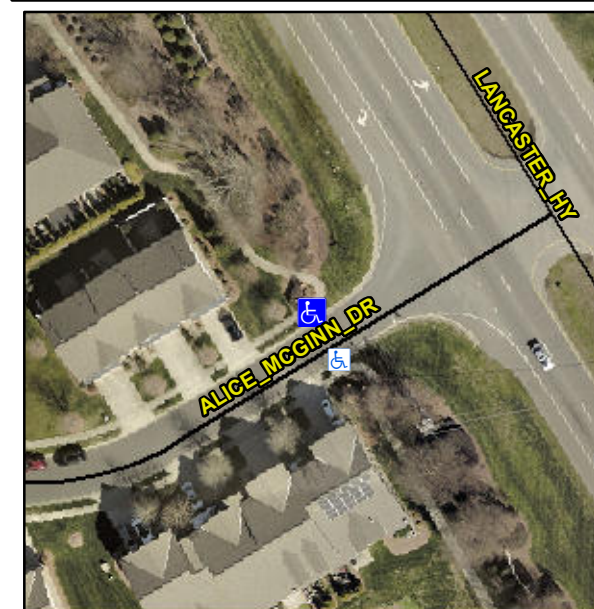
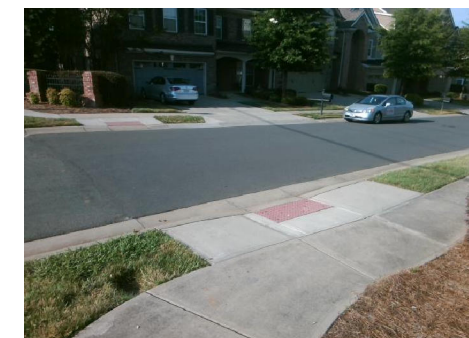
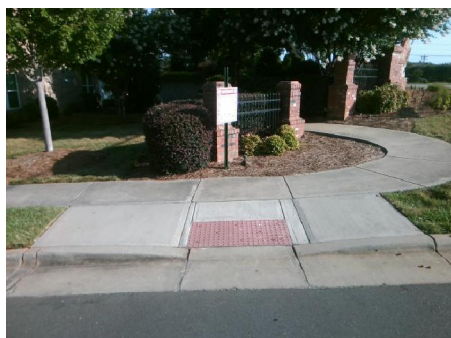
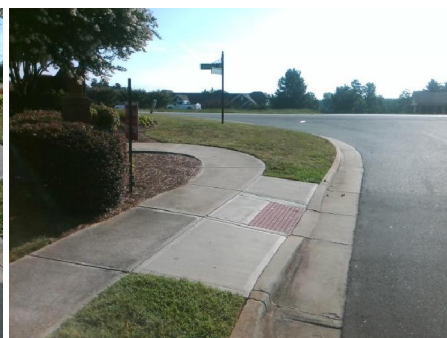
Not Found, R304.2.2, R304.5.3

Compliance	Description	Data	Compliance	Description	Data
N/A	Ramp Length (in)	49.0	No	Ramp Slope (%)	10.4
Yes	Ramp Width (in)	48.0	No	Ramp XSlope (%)	3.4
N/A	Flare Type LT	N/A	N/A	Flare Type RT	N/A
N/A	Flare Slope LT (%)	N/A	N/A	Flare Slope RT (%)	N/A
N/A	Flare Traversable LT?	N/A	N/A	Flare Traversable RT?	N/A
N/A	Landing Length (in)	N/A	N/A	DWS Provided?	N/A
N/A	Landing Width (in)	N/A	N/A	DWS Contrast?	N/A
N/A	Landing Slope (%)	N/A	N/A	DWS Length (in)	N/A
N/A	Landing X Slope (%)	N/A	N/A	DWS Full Width?	N/A
N/A	Landing Curb? (Y/N)	N/A	N/A	DWS Offset (in)	N/A
N/A	Shared Landing?	N/A			
N/A	Gutter Ponding?	N/A	N/A	Gutter Slope (%)	N/A
N/A	Gutter Lip Ht (in)	N/A	N/A	Gutter X Slope (%)	N/A
N/A	Painted X Walk1?	No	N/A	Painted X Walk2?	N/A
	X Walk 1 Direction	To SE		X Walk 2 Direction	N/A
N/A	X Walk 1 Width (in)	N/A	N/A	X Walk 2 Width (in)	N/A
	X Walk 1 Slope (%)	5.3		X Walk 2 Slope (%)	N/A
	X Walk 1 X Slope (%)	2.7		X Walk 2 X Slope (%)	N/A

N/A	Ramp inside XWalk1?	N/A	N/A	Ramp inside XWalk2?	N/A
	Road Slope (%)	N/A	N/A	Clear Space?	N/A
	Road X Slope (%)	N/A	N/A	Clear Space to XWalk (in)	N/A
N/A	Any Obstructions?	N/A	N/A	Storm Grate/Utility Hazard?	N/A
	Obstruction Type			Storm Grate/Utility Type	
		N/A			N/A
			Yes	Surface Condition? (G/P)	Good

Remove & Replace Entire Ramp.
