Access Compliance Report

Public Rights-of-Way

(Curb Ramps)

Intersection ID: 27397	Main Street: ELM_LN	Cross Street: BALLANTYNE_COMMONS_PY	Location: SE
ADA ID: 8B376F743C1A	Ramp Type: Perp	Initial Pass/Fail: Fail	Overall Compliance: No
Severity Score: 13.75			
Codes/Mitigation Info/Possible Solution		Field Measurements/Component Compliance

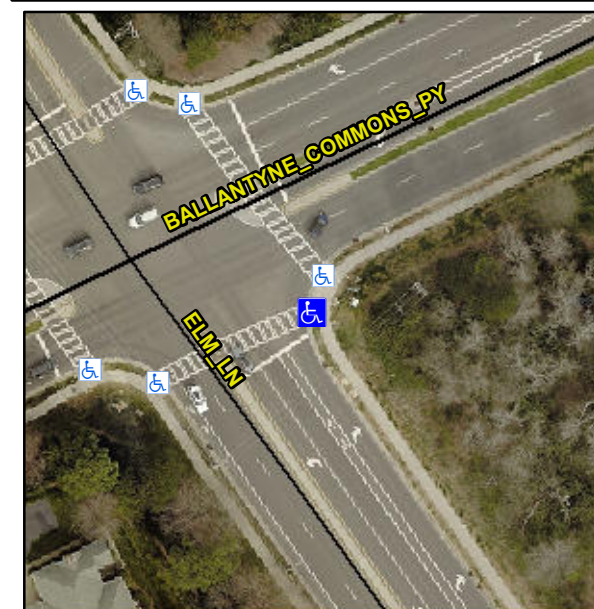
R304.2.2, R304.5.3

Compliance	Description	Data	Compliance	Description	Data
N/A	Ramp Length (in)	48.0	No	Ramp Slope (%)	9.0
Yes	Ramp Width (in)	48.0	No	Ramp XSlope (%)	2.5
N/A	Flare Type LT	N/A	N/A	Flare Type RT	N/A
N/A	Flare Slope LT (%)	N/A	N/A	Flare Slope RT (%)	N/A
N/A	Flare Traversable LT?	N/A	N/A	Flare Traversable RT?	N/A
N/A	Landing Length (in)	N/A	N/A	DWS Provided?	N/A
N/A	Landing Width (in)	N/A	N/A	DWS Contrast?	N/A
N/A	Landing Slope (%)	N/A	N/A	DWS Length (in)	N/A
N/A	Landing X Slope (%)	N/A	N/A	DWS Full Width?	N/A
N/A	Landing Curb? (Y/N)	N/A	N/A	DWS Offset (in)	N/A
N/A	Shared Landing?	N/A			
N/A	Gutter Ponding?	N/A	N/A	Gutter Slope (%)	N/A
N/A	Gutter Lip Ht (in)	N/A	N/A	Gutter X Slope (%)	N/A
N/A	Painted X Walk1?	Yes	N/A	Painted X Walk2?	N/A
	X Walk 1 Direction	To SW		X Walk 2 Direction	N/A
N/A	X Walk 1 Width (in)	112.0	N/A	X Walk 2 Width (in)	N/A
	X Walk 1 Slope (%)	3.9		X Walk 2 Slope (%)	N/A
	X Walk 1 X Slope (%)	2.2		X Walk 2 X Slope (%)	N/A

Remove & Replace Entire Ramp.
