Access Compliance Report Public Rights-of-Way (Curb Ramps)

Intersection ID: 3984 Main Street: GENOA_LN **Cross Street: HALLIWELL_ST** Location: W Overall Compliance: No **Severity Score:** ADA ID: 8B3E8E80378D Ramp Type: Perp Initial Pass/Fail: Fail 25

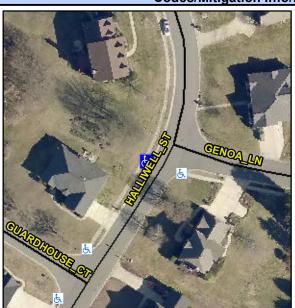
Field Measurements/Component Compliance							
Comp	liance Description	Data	Comp	liance Description	Data		
N/A	Ramp Length (in)	45.0	Yes	Ramp Slope (%)	5.0		
Yes	Ramp Width (in)	88.0	No	Ramp XSlope (%)	10.0		
N/A	Flare Type LT	N/A	N/A	Flare Type RT	N/A		
N/A	Flare Slope LT (%)	N/A	N/A	Flare Slope RT (%)	N/A		
N/A	Flare Traversable LT?	N/A	N/A	Flare Traversable RT?	N/A		
N/A	Landing Length (in)	N/A	N/A	DWS Provided?	N/A		
N/A	Landing Width (in)	N/A	N/A	DWS Contrast?	N/A		
N/A	Landing Slope (%)	N/A	N/A	DWS Length (in)	N/A		
N/A	Landing X Slope (%)	N/A	N/A	DWS Full Width?	N/A		
N/A	Landing Curb? (Y/N)	N/A	N/A	DWS Offset (in)	N/A		
N/A	Shared Landing?	N/A					
N/A	Gutter Ponding?	N/A	N/A	Gutter Slope (%)	N/A		
N/A	Gutter Lip Ht (in)	N/A	N/A	Gutter X Slope (%)	N/A		
N/A	Painted X Walk1?	No	N/A	Painted X Walk2?	N/A		
	X Walk 1 Direction	To SE		X Walk 2 Direction	N/A		
N/A	X Walk 1 Width (in)	N/A	N/A	X Walk 2 Width (in)	N/A

X Walk 1 Slope (%)	6.2		X Walk 2 Slope (%)	N/A		
	X Walk 1 X Slope (%)	11.9		X Walk 2 X Slope (%)	N/A		
N/A	Ramp inside XWalk1?	N/A	N/A	Ramp inside XWalk2?	N/A		
	Road Slope (%)	N/A	N/A	Clear Space?	N/A		
	Road X Slope (%)	N/A	N/A	Clear Space to XWalk (in)	N/A		
N/A	Any Obstructions?	N/A	N/A	Storm Grate/Utility Hazard?	N/A		
	Obstruction Type			Storm Grate/Utility Type			
		N/A			N/A		
			Yes	Surface Condition? (G/P)	Good		
1

Cocibio Colution		
Possible Solutions:		
Remove & Replace Entire Ramp.		
	,	
	I	
	I	
	I	
	ı	
Surveyor Notes:		
N/A	I	
	I	
DDOW/ADA		
PROW/ADA:		
Not Found, R304.5.3

Total Cost:	\$ 1850.00
