Access Compliance Report

Public Rights-of-Way

(Curb Ramps)

Intersection ID: 44016	Main Street: ATWATER_LN	Cross Street: MANTARIO_DR	Location: E
ADA ID: 8B40735BD266	Ramp Type: PerpDiag	Initial Pass/Fail: Fail	Overall Compliance: No
		Severity Score: 17.5

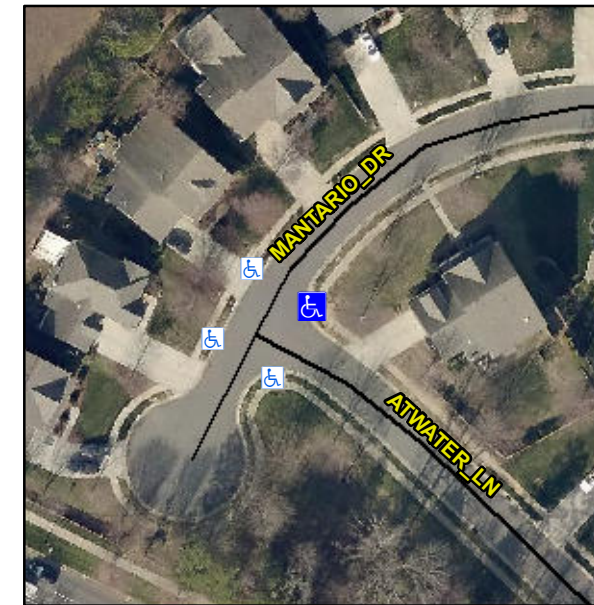
Compliance	Description	Data	Compliance	Description	Data
N/A	Ramp Length (in)	45.5	Yes	Ramp Slope (%)	5.9
No	Ramp Width (in)	34.0	Yes	Ramp XSlope (%)	0.6
N/A	Flare Type LT	N/A	N/A	Flare Type RT	N/A
N/A	Flare Slope LT (%)	N/A	N/A	Flare Slope RT (%)	N/A
N/A	Flare Traversable LT?	N/A	N/A	Flare Traversable RT?	N/A
N/A	Landing Length (in)	N/A	N/A	DWS Provided?	N/A
N/A	Landing Width (in)	N/A	N/A	DWS Contrast?	N/A
N/A	Landing Slope (%)	N/A	N/A	DWS Length (in)	N/A
N/A	Landing X Slope (%)	N/A	N/A	DWS Full Width?	N/A
N/A	Landing Curb? (Y/N)	N/A	N/A	DWS Offset (in)	N/A
N/A	Shared Landing?	N/A			
N/A	Gutter Ponding?	N/A	N/A	Gutter Slope (%)	N/A
N/A	Gutter Lip Ht (in)	N/A	N/A	Gutter X Slope (%)	N/A
N/A	Painted X Walk1?	No	N/A	Painted X Walk2?	No
	X Walk 1 Direction	To NW		X Walk 2 Direction	To SW
N/A	X Walk 1 Width (in)	N/A	N/A	X Walk 2 Width (in)	N/A
	X Walk 1 Slope (%)	0.9		X Walk 2 Slope (%)	0.4
	X Walk 1 X Slope (%)	3.7		X Walk 2 X Slope (%)	1.9

N/A	Ramp inside XWalk1?	N/A	N/A	Ramp inside XWalk2?	N/A
	Road Slope (%)	0.7	N/A	Clear Space?	N/A
	Road X Slope (%)	4.7	N/A	Clear Space to XWalk (in)	N/A
N/A	Any Obstructions?	N/A	N/A	Storm Grate/Utility Hazard?	N/A
	Obstruction Type			Storm Grate/Utility Type	
		N/A			N/A
			Yes	Surface Condition? (G/P)	Good

Possible Solutions:

Remove & Replace Curb Ramp With Two New Directional Ramps or Equivalent.

R304.5.1

Total Cost: \$ 3200.00
