Access Compliance Report

Public Rights-of-Way

(Curb Ramps)

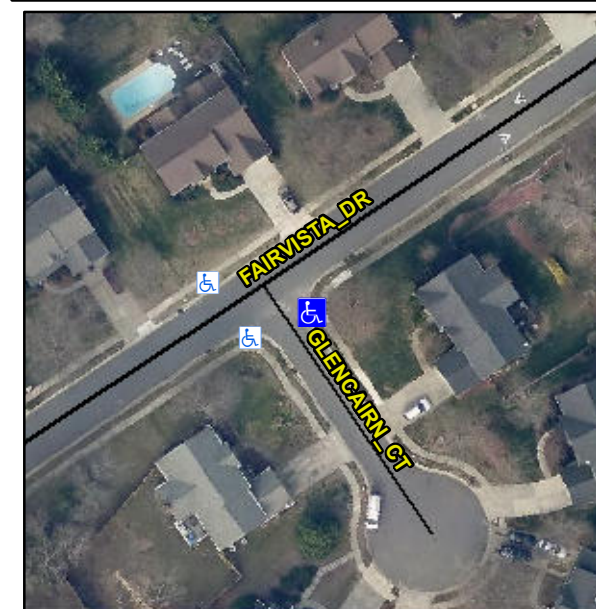
Intersection ID: 2617	Main Street: FAIRVISTA_DR	Cross Street: GLENCAIRN_CT	Location: SE
ADA ID: 8B44EFB0B559	Ramp Type: Perp	Initial Pass/Fail: Fail	Overall Compliance: No
Severity Score: 21.25			
Codes/Mitigation Info/Possible Solution		Field Measurements/Component Compliance

Not Found, R304.5.1, R304.2.2

Compliance	Description	Data	Compliance	Description	Data
N/A	Ramp Length (in)	53.0	No	Ramp Slope (%)	11.2
No	Ramp Width (in)	36.5	Yes	Ramp XSlope (%)	0.0
N/A	Flare Type LT	N/A	N/A	Flare Type RT	N/A
N/A	Flare Slope LT (%)	N/A	N/A	Flare Slope RT (%)	N/A
N/A	Flare Traversable LT?	N/A	N/A	Flare Traversable RT?	N/A
N/A	Landing Length (in)	N/A	N/A	DWS Provided?	N/A
N/A	Landing Width (in)	N/A	N/A	DWS Contrast?	N/A
N/A	Landing Slope (%)	N/A	N/A	DWS Length (in)	N/A
N/A	Landing X Slope (%)	N/A	N/A	DWS Full Width?	N/A
N/A	Landing Curb? (Y/N)	N/A	N/A	DWS Offset (in)	N/A
N/A	Shared Landing?	N/A			
N/A	Gutter Ponding?	N/A	N/A	Gutter Slope (%)	N/A
N/A	Gutter Lip Ht (in)	N/A	N/A	Gutter X Slope (%)	N/A
N/A	Painted X Walk1?	No	N/A	Painted X Walk2?	N/A
	X Walk 1 Direction	To W		X Walk 2 Direction	N/A
N/A	X Walk 1 Width (in)	N/A	N/A	X Walk 2 Width (in)	N/A
	X Walk 1 Slope (%)	0.5		X Walk 2 Slope (%)	N/A
	X Walk 1 X Slope (%)	1.7		X Walk 2 X Slope (%)	N/A

N/A	Ramp inside XWalk1?	N/A	N/A	Ramp inside XWalk2?	N/A
	Road Slope (%)	N/A	N/A	Clear Space?	N/A
	Road X Slope (%)	N/A	N/A	Clear Space to XWalk (in)	N/A
N/A	Any Obstructions?	N/A	N/A	Storm Grate/Utility Hazard?	N/A
	Obstruction Type			Storm Grate/Utility Type	
		N/A			N/A
			Yes	Surface Condition? (G/P)	Good

Possible Solutions:

Remove & Replace Entire Ramp.
