Access Compliance Report Public Rights-of-Way (Curb Ramps)

Intersection ID: 18017 Main Street: CHELSEA_DR Cross Street: DELLWOOD_AV Location: SE

ADA ID: 8B4674AA800E Ramp Type: Perp Initial Pass/Fail: Fail Overall Compliance: No Severity Score: 26.25

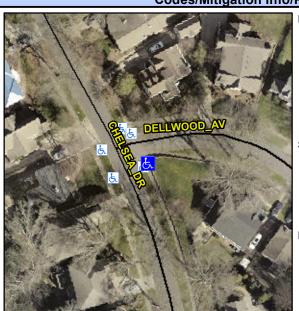
R304.2.2, R304.5.3

Fleid Measurements/Component Compliance					
Compliance Description			Compliance Description		Data
N/A	Ramp Length (in)	75.0	No	Ramp Slope (%)	17.2
Yes	Ramp Width (in)	50.0	No	Ramp XSlope (%)	2.6
N/A	Flare Type LT	N/A	N/A	Flare Type RT	N/A
N/A	Flare Slope LT (%)	N/A	N/A	Flare Slope RT (%)	N/A
N/A	Flare Traversable LT?	N/A	N/A	Flare Traversable RT?	N/A
N/A	Landing Length (in)	N/A	N/A	DWS Provided?	N/A
N/A	Landing Width (in)	N/A	N/A	DWS Contrast?	N/A
N/A	Landing Slope (%)	N/A	N/A	DWS Length (in)	N/A
N/A	Landing X Slope (%)	N/A	N/A	DWS Full Width?	N/A
N/A	Landing Curb? (Y/N)	N/A	N/A	DWS Offset (in)	N/A
N/A	Shared Landing?	N/A			
N/A	Gutter Ponding?	N/A	N/A	Gutter Slope (%)	N/A
N/A	Gutter Lip Ht (in)	N/A	N/A	Gutter X Slope (%)	N/A
N/A	Painted X Walk1?	No	N/A	Painted X Walk2?	N/A
	X Walk 1 Direction	To N		X Walk 2 Direction	N/A
N/A	X Walk 1 Width (in)	N/A	N/A	X Walk 2 Width (in)	N/A
	X Walk 1 Slope (%)	4.6		X Walk 2 Slope (%)	N/A

X Walk 1 X Slope (%)	3.2		X Walk 2 X Slope (%)	N/A
N/A	Ramp inside XWalk1?	N/A	N/A	Ramp inside XWalk2?	N/A
	Road Slope (%)	N/A	N/A	Clear Space?	N/A
	Road X Slope (%)	N/A	N/A	Clear Space to XWalk (in)	N/A
N/A	Any Obstructions?	N/A	N/A	Storm Grate/Utility Hazard?	N/A
	Obstruction Type			Storm Grate/Utility Type	
		N/A			N/A
			Yes	Surface Condition? (G/P)	Good

Remove & Replace Entire Ramp.
