Access Compliance Report

Public Rights-of-Way

(Curb Ramps)

Intersection ID: 12412	Main Street: BELMONT_AV	Cross Street: PEGRAM_ST	Location: S
ADA ID: 8B4975B0CA6D	Ramp Type: BlendTrans1	Initial Pass/Fail: Fail	Overall Compliance: No
		Severity Score: 8.75

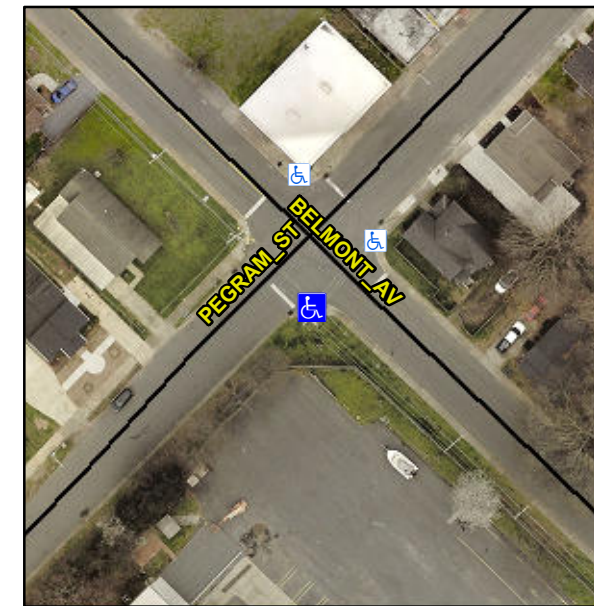
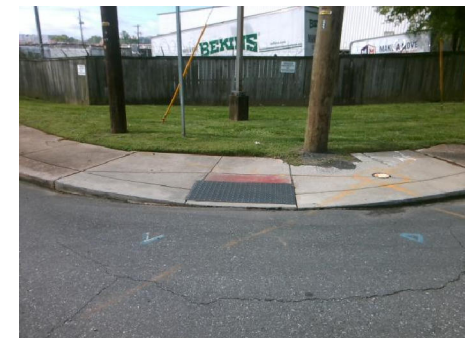
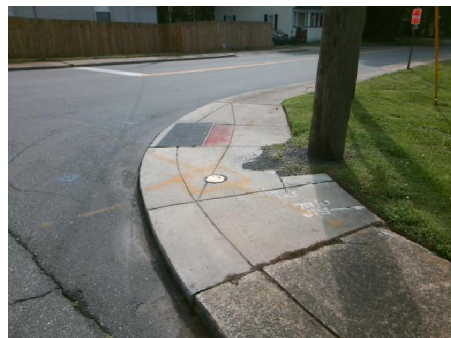
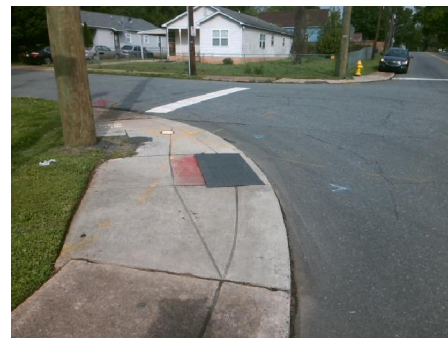
Compliance	Description	Data	Compliance	Description	Data
N/A	Ramp Length (in)	25.5	Yes	BlendTrans Slope (%)	1.2
No	Ramp Width (in)	43.0	Yes	BlendTrans XSlope (%)	1.9
N/A	Flare Type LT	N/A	N/A	Flare Type RT	N/A
N/A	Flare Slope LT (%)	N/A	N/A	Flare Slope RT (%)	N/A
N/A	Flare Traversable LT?	N/A	N/A	Flare Traversable RT?	N/A
N/A	Landing Length (in)	N/A	N/A	DWS Provided?	N/A
N/A	Landing Width (in)	N/A	N/A	DWS Contrast?	N/A
N/A	Landing Slope (%)	N/A	N/A	DWS Length (in)	N/A
N/A	Landing X Slope (%)	N/A	N/A	DWS Full Width?	N/A
N/A	Landing Curb? (Y/N)	N/A	N/A	DWS Offset (in)	N/A
N/A	Shared Landing?	N/A			
N/A	Gutter Ponding?	N/A	N/A	Gutter Slope (%)	N/A
N/A	Gutter Lip Ht (in)	0.5	N/A	Gutter X Slope (%)	N/A
N/A	Painted X Walk1?	No	N/A	Painted X Walk2?	No
	X Walk 1 Direction	To NE		X Walk 2 Direction	To NW
	X Walk 1 Width (in)	N/A		X Walk 2 Width (in)	N/A
	X Walk 1 Slope (%)	2.3		X Walk 2 Slope (%)	5.9
	X Walk 1 X Slope (%)	3.7		X Walk 2 X Slope (%)	0.7

N/A	Ramp inside XWalk1?	N/A	N/A	Ramp inside XWalk2?	N/A
	Road Slope (%)	2.8		Clear Space?	N/A
	Road X Slope (%)	2.5	N/A	Clear Space to XWalk (in)	N/A
N/A	Any Obstructions?	N/A	N/A	Storm Grate/Utility Hazard?	N/A
	Obstruction Type			Storm Grate/Utility Type	
		N/A			N/A
			Yes	Surface Condition? (G/P)	Good
			N/A	Curb Slope (%)	3.6

Possible Solutions:

Remove & Replace Curb Ramp With Two New Directional Ramps or Equivalent.

R304.5.1
