# Access Compliance Report

## Public Rights-of-Way

### (Curb Ramps)

| Intersection ID: 50234 | Main Street: LONGSTONE_LN | Cross Street: RIVERSTONE_WY | Location: S |

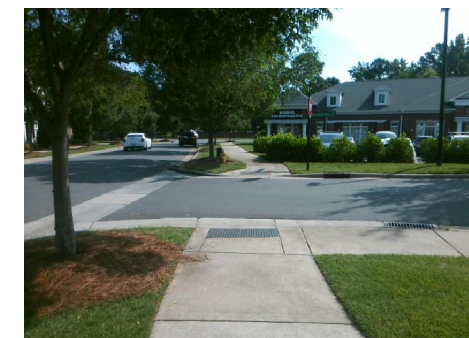
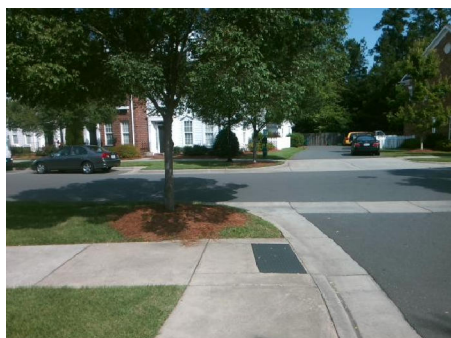
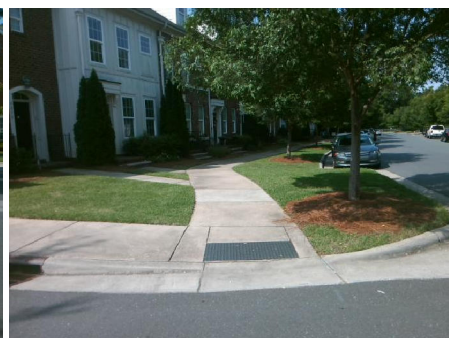
| ADA ID: 8B4C6881F1AD | Ramp Type: Perp | Initial Pass/Fail: Pass | Overall Compliance: No |

**Not Found, R304.2.1, R304.2.2-Perp,  
R304.3.2-Para, R304.5.3**

| Compliance | Description | Data | Compliance | Description | Data |
|---|---|---|---|---|---|
| No | Landing Length (in) | 31.0 | Yes | DWS Provided? | Yes |
| No | Landing Slope (%) | 2.9 | Yes | DWS Length (in) | 24.0 |
| Yes | Gutter Lip Ht (in) | 0.0 | No | Gutter X Slope (%) | 2.1 |

**Remove & Replace Entire Ramp.  
Remove & Replace Gutter.**
