Access Compliance Report

Public Rights-of-Way

(Curb Ramps)

| Intersection ID: 51369 | Main Street: UNIVERSITY_CITY_BV | Cross Street: IKEA_BV | Location: SE |

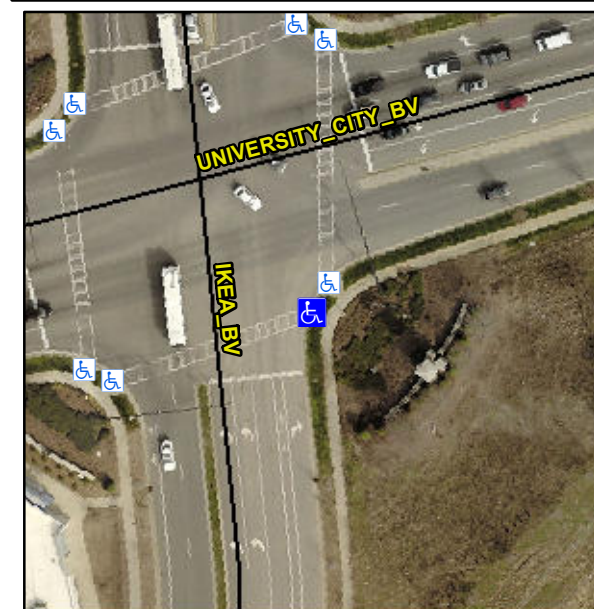
| ADA ID: 8B61CBAA2994 | Ramp Type: Perp | Initial Pass/Fail: Fail | Overall Compliance: No |
| Severity Score: 8.75 | | | |

Not Found, R304.5.1

| Compliance | Description | Data | Compliance | Description | Data |
|---|---|---|---|---|---|
| N/A | Ramp Length (in) | 96.0 | Yes | Ramp Slope (%) | 7.7 |
| No | Ramp Width (in) | 47.0 | Yes | Ramp XSlope (%) | 0.5 |

Possible Solutions:

Remove & Replace Entire Ramp.

Total Cost: \$ 1850.00
