Access Compliance Report

Public Rights-of-Way

(Curb Ramps)

Intersection ID: 24499	Main Street: BECKMORE_PL	Cross Street: SAINTFIELD_PL	Location: NE
ADA ID: 8B638DA8AD39	Ramp Type: Perp	Initial Pass/Fail: Pass	Overall Compliance: No
Severity Score: 2.5			
Codes/Mitigation Info/Possible Solution		Field Measurements/Component Compliance

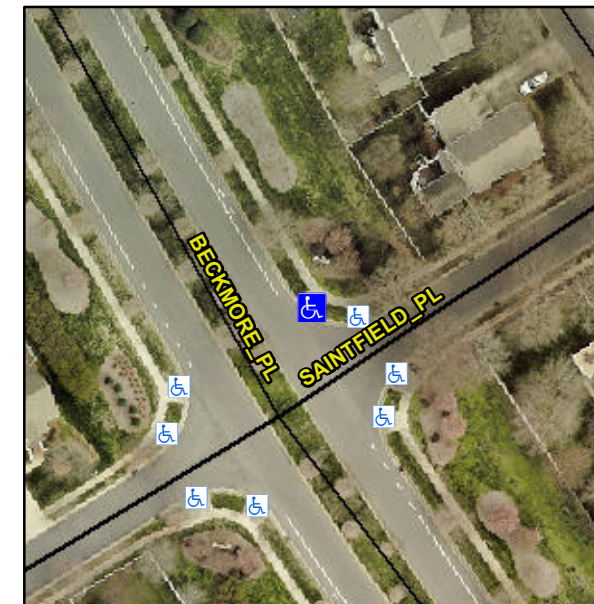
Not Found, R305.1.4, R305.2

Compliance	Description	Data	Compliance	Description	Data
N/A	Ramp Length (in)	94.0	Yes	Ramp Slope (%)	7.7
Yes	Ramp Width (in)	71.0	Yes	Ramp XSlope (%)	1.4
N/A	Flare Type LT	Sloped	N/A	Flare Type RT	N/A
N/A	Flare Slope LT (%)	8.8	Yes	Flare Slope RT (%)	8.1
N/A	Flare Traversable LT?	Yes	N/A	Flare Traversable RT?	Yes
Yes	Landing Length (in)	62.0	Yes	DWS Provided?	Yes
Yes	Landing Width (in)	71.0	Yes	DWS Contrast?	Yes
Yes	Landing Slope (%)	2.0	Yes	DWS Length (in)	25.5
Yes	Landing X Slope (%)	1.6	No	DWS Full Width?	No
N/A	Landing Curb? (Y/N)	No	No	DWS Offset (in)	3.0
N/A	Shared Landing?	No			
Yes	Gutter Ponding?	No	Yes	Gutter Slope (%)	2.0
Yes	Gutter Lip Ht (in)	0.0	Yes	Gutter X Slope (%)	1.0
N/A	Painted X Walk1?	No	N/A	Painted X Walk2?	N/A
	X Walk 1 Direction	To W		X Walk 2 Direction	N/A
N/A	X Walk 1 Width (in)	N/A	N/A	X Walk 2 Width (in)	N/A
	X Walk 1 Slope (%)	2.4		X Walk 2 Slope (%)	N/A
	X Walk 1 X Slope (%)	8.9		X Walk 2 X Slope (%)	N/A

N/A	Ramp inside XWalk1?	N/A	N/A	Ramp inside XWalk2?	N/A
	Road Slope (%)	N/A	N/A	Clear Space?	Yes
	Road X Slope (%)	N/A	N/A	Clear Space to XWalk (in)	N/A
Yes	Any Obstructions?	No	Yes	Storm Grate/Utility Hazard?	No
	Obstruction Type			Storm Grate/Utility Type	
		N/A			N/A
			Yes	Surface Condition? (G/P)	Good

Possible Solutions:

Remove & Replace Entire Ramp.
