Access Compliance Report

Public Rights-of-Way

(Curb Ramps)

Intersection ID: 30536	Main Street: S_TRYON_ST	Cross Street: BENNINGTON_PLACE_DR	Location: N
ADA ID: 8B7AC6413830	Ramp Type: PerpDiag	Initial Pass/Fail: Fail	Overall Compliance: No
Severity Score: 21.25			
Codes/Mitigation Info/Possible Solution		Field Measurements/Component Compliance

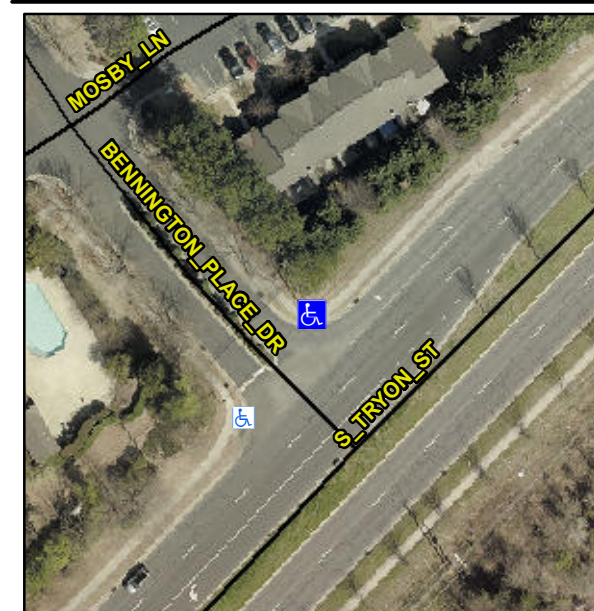
Compliance	Description	Data	Compliance	Description	Data
N/A	Ramp Length (in)	58.0	No	Ramp Slope (%)	11.6
No	Ramp Width (in)	47.0	Yes	Ramp XSlope (%)	2.0
N/A	Flare Type LT	N/A	N/A	Flare Type RT	N/A
N/A	Flare Slope LT (%)	N/A	N/A	Flare Slope RT (%)	N/A
N/A	Flare Traversable LT?	N/A	N/A	Flare Traversable RT?	N/A
N/A	Landing Length (in)	N/A	N/A	DWS Provided?	N/A
N/A	Landing Width (in)	N/A	N/A	DWS Contrast?	N/A
N/A	Landing Slope (%)	N/A	N/A	DWS Length (in)	N/A
N/A	Landing X Slope (%)	N/A	N/A	DWS Full Width?	N/A
N/A	Landing Curb? (Y/N)	N/A	N/A	DWS Offset (in)	N/A
N/A	Shared Landing?	N/A			
N/A	Gutter Ponding?	N/A	N/A	Gutter Slope (%)	N/A
N/A	Gutter Lip Ht (in)	N/A	N/A	Gutter X Slope (%)	N/A
N/A	Painted X Walk1?	No	N/A	Painted X Walk2?	No
	X Walk 1 Direction	To SW		X Walk 2 Direction	To SE
N/A	X Walk 1 Width (in)	N/A	N/A	X Walk 2 Width (in)	N/A
	X Walk 1 Slope (%)	1.2		X Walk 2 Slope (%)	0.5
	X Walk 1 X Slope (%)	0.9		X Walk 2 X Slope (%)	0.6

N/A	Ramp inside XWalk1?	N/A	N/A	Ramp inside XWalk2?	N/A
	Road Slope (%)	2.4	N/A	Clear Space?	N/A
	Road X Slope (%)	0.2	N/A	Clear Space to XWalk (in)	N/A
N/A	Any Obstructions?	N/A	N/A	Storm Grate/Utility Hazard?	N/A
	Obstruction Type			Storm Grate/Utility Type	
		N/A			N/A
			Yes	Surface Condition? (G/P)	Good

Possible Solutions:

Remove & Replace Curb Ramp With Two New Directional Ramps or Equivalent.

R304.5.1, R304.2.2
