Access Compliance Report

Public Rights-of-Way

(Curb Ramps)

Intersection ID: 17250	Main Street: CROYDON_RD	Cross Street: QUEENS_RD_WEST	Location: SE
ADA ID: 8B82ACBF2A9B	Ramp Type: Perp	Initial Pass/Fail: Fail	Overall Compliance: No
Severity Score: 1.25			
Codes/Mitigation Info/Possible Solution		Field Measurements/Component Compliance

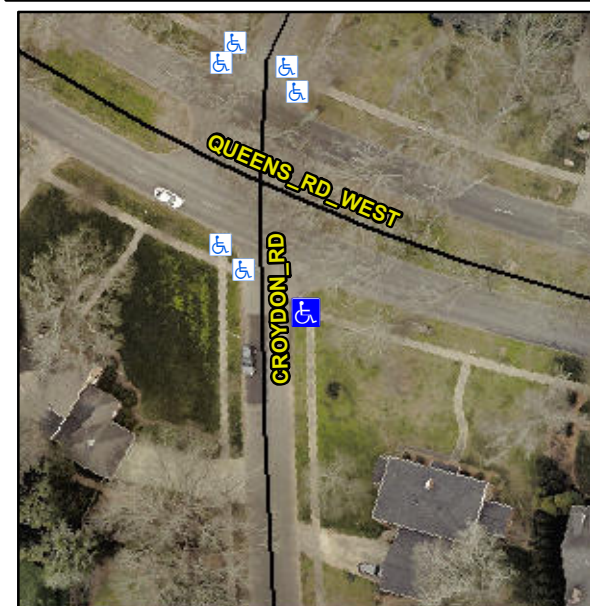
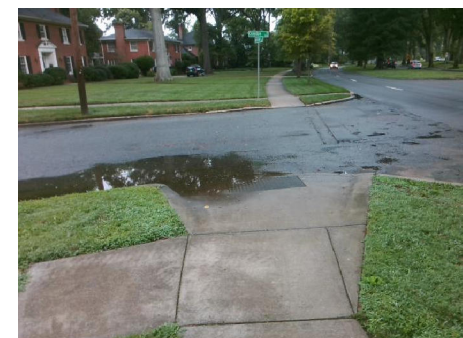
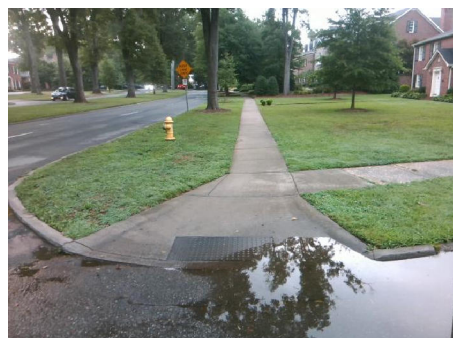
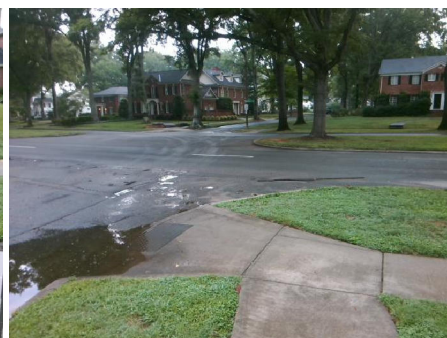
R304.5.3

Compliance	Description	Data	Compliance	Description	Data
N/A	Ramp Length (in)	116.0	Yes	Ramp Slope (%)	7.2
Yes	Ramp Width (in)	48.0	No	Ramp XSlope (%)	2.2
N/A	Flare Type LT	N/A	N/A	Flare Type RT	N/A
N/A	Flare Slope LT (%)	N/A	N/A	Flare Slope RT (%)	N/A
N/A	Flare Traversable LT?	N/A	N/A	Flare Traversable RT?	N/A
N/A	Landing Length (in)	N/A	N/A	DWS Provided?	N/A
N/A	Landing Width (in)	N/A	N/A	DWS Contrast?	N/A
N/A	Landing Slope (%)	N/A	N/A	DWS Length (in)	N/A
N/A	Landing X Slope (%)	N/A	N/A	DWS Full Width?	N/A
N/A	Landing Curb? (Y/N)	N/A	N/A	DWS Offset (in)	N/A
N/A	Shared Landing?	N/A			
N/A	Gutter Ponding?	Yes	N/A	Gutter Slope (%)	N/A
N/A	Gutter Lip Ht (in)	N/A	N/A	Gutter X Slope (%)	N/A
N/A	Painted X Walk1?	No	N/A	Painted X Walk2?	N/A
	X Walk 1 Direction	To NW		X Walk 2 Direction	N/A
N/A	X Walk 1 Width (in)	N/A	N/A	X Walk 2 Width (in)	N/A
	X Walk 1 Slope (%)	0.1		X Walk 2 Slope (%)	N/A
	X Walk 1 X Slope (%)	0.3		X Walk 2 X Slope (%)	N/A

N/A	Ramp inside XWalk1?	N/A	N/A	Ramp inside XWalk2?	N/A
	Road Slope (%)	N/A	N/A	Clear Space?	N/A
	Road X Slope (%)	N/A	N/A	Clear Space to XWalk (in)	N/A
N/A	Any Obstructions?	N/A	N/A	Storm Grate/Utility Hazard?	N/A
	Obstruction Type			Storm Grate/Utility Type	
		N/A			N/A
		Yes		Surface Condition? (G/P)	Good

Possible Solutions:

Remove & Replace Entire Ramp.

Total Cost: \$ 1850.00
