Access Compliance Report

Public Rights-of-Way

(Curb Ramps)

Intersection ID: 3679	Main Street: BRIDLE_RIDGE_LN	Cross Street: DAVIS_LAKE_PY	Location: NE
ADA ID: 8B85BE52A13B	Ramp Type: Perp	Initial Pass/Fail: Fail	Overall Compliance: No
Codes/Mitigation Info/Possible Solution		Field Measurements/Component Compliance

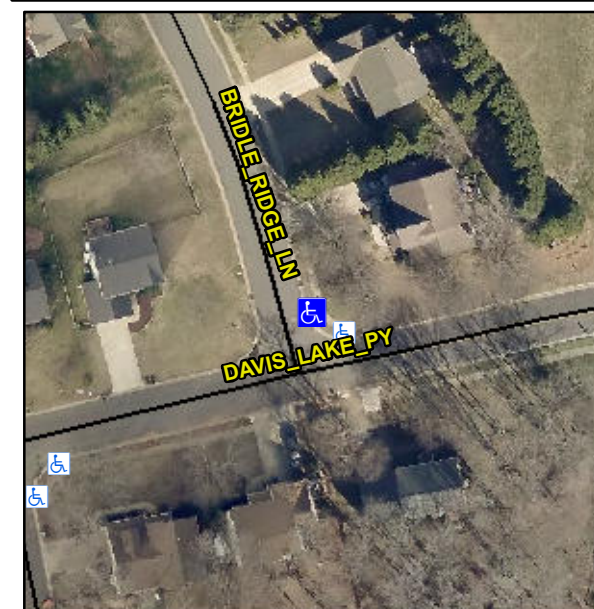
PROW/ADA:

Not Found, R304.5.1, R304.5.3

Compliance	Description	Data	Compliance	Description	Data
N/A	Ramp Length (in)	49.0	Yes	Ramp Slope (%)	5.7
No	Ramp Width (in)	42.5	No	Ramp XSlope (%)	3.8
N/A	Flare Type LT	N/A	N/A	Flare Type RT	N/A
N/A	Flare Slope LT (%)	N/A	N/A	Flare Slope RT (%)	N/A
N/A	Flare Traversable LT?	N/A	N/A	Flare Traversable RT?	N/A
N/A	Landing Length (in)	N/A	N/A	DWS Provided?	N/A
N/A	Landing Width (in)	N/A	N/A	DWS Contrast?	N/A
N/A	Landing Slope (%)	N/A	N/A	DWS Length (in)	N/A
N/A	Landing X Slope (%)	N/A	N/A	DWS Full Width?	N/A
N/A	Landing Curb? (Y/N)	N/A	N/A	DWS Offset (in)	N/A
N/A	Shared Landing?	N/A			
N/A	Gutter Ponding?	N/A	N/A	Gutter Slope (%)	N/A
N/A	Gutter Lip Ht (in)	N/A	N/A	Gutter X Slope (%)	N/A
N/A	Painted X Walk1?	No	N/A	Painted X Walk2?	N/A
	X Walk 1 Direction	To W		X Walk 2 Direction	N/A
N/A	X Walk 1 Width (in)	N/A	N/A	X Walk 2 Width (in)	N/A
	X Walk 1 Slope (%)	2.0		X Walk 2 Slope (%)	N/A
	X Walk 1 X Slope (%)	3.5		X Walk 2 X Slope (%)	N/A

N/A	Ramp inside XWalk1?	N/A	N/A	Ramp inside XWalk2?	N/A
	Road Slope (%)	N/A	N/A	Clear Space?	N/A
	Road X Slope (%)	N/A	N/A	Clear Space to XWalk (in)	N/A
N/A	Any Obstructions?	N/A	N/A	Storm Grate/Utility Hazard?	N/A
	Obstruction Type			Storm Grate/Utility Type	
		N/A			N/A
			Yes	Surface Condition? (G/P)	Good

Possible Solutions:

Remove & Replace Entire Ramp.
