Access Compliance Report

Public Rights-of-Way

(Curb Ramps)

Intersection ID: 45182	Main Street: MAPLEHURST_DR	Cross Street: SOCIETY_ST	Location:	NW
ADA ID: 8B8F9E67C67D	Ramp Type: PerpDiag	Initial Pass/Fail: Fail	Overall Compliance: No	Severity Score: 10

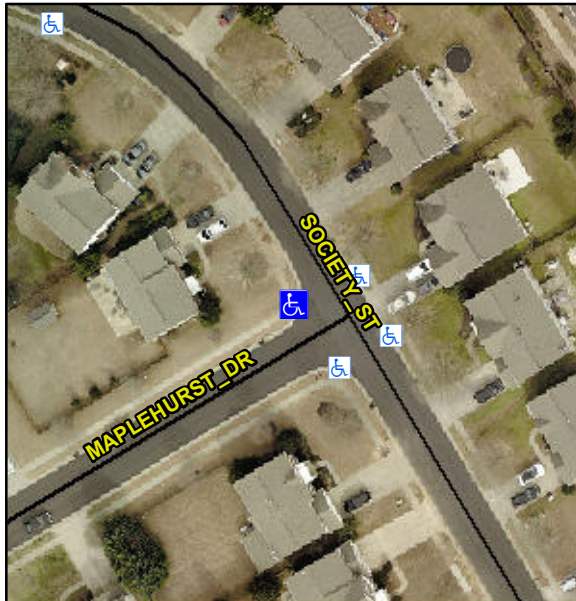
Not Found, R304.5.1, R304.5.3

Compliance	Description	Data	Compliance	Description	Data
N/A	Ramp Length (in)	96.0	Yes	Ramp Slope (%)	5.6
No	Ramp Width (in)	37.5	No	Ramp XSlope (%)	2.5
N/A	Flare Type LT	N/A	N/A	Flare Type RT	N/A
N/A	Flare Slope LT (%)	N/A	N/A	Flare Slope RT (%)	N/A
N/A	Flare Traversable LT?	N/A	N/A	Flare Traversable RT?	N/A
N/A	Landing Length (in)	N/A	N/A	DWS Provided?	N/A
N/A	Landing Width (in)	N/A	N/A	DWS Contrast?	N/A
N/A	Landing Slope (%)	N/A	N/A	DWS Length (in)	N/A
N/A	Landing X Slope (%)	N/A	N/A	DWS Full Width?	N/A
N/A	Landing Curb? (Y/N)	N/A	N/A	DWS Offset (in)	N/A
N/A	Shared Landing?	N/A			
N/A	Gutter Ponding?	N/A	N/A	Gutter Slope (%)	N/A
N/A	Gutter Lip Ht (in)	N/A	N/A	Gutter X Slope (%)	N/A
N/A	Painted X Walk1?	No	N/A	Painted X Walk2?	No
	X Walk 1 Direction	To SE		X Walk 2 Direction	To NE
N/A	X Walk 1 Width (in)	N/A	N/A	X Walk 2 Width (in)	N/A
	X Walk 1 Slope (%)	1.2		X Walk 2 Slope (%)	4.0
	X Walk 1 X Slope (%)	4.2		X Walk 2 X Slope (%)	0.8

N/A	Ramp inside XWalk1?	N/A	N/A	Ramp inside XWalk2?	N/A
	Road Slope (%)	3.5	N/A	Clear Space?	N/A
	Road X Slope (%)	4.6	N/A	Clear Space to XWalk (in)	N/A
N/A	Any Obstructions?	N/A	N/A	Storm Grate/Utility Hazard?	N/A
	Obstruction Type			Storm Grate/Utility Type	
		N/A			N/A
			Yes	Surface Condition? (G/P)	Good

Remove & Replace Curb Ramp With Two New Directional Ramps or Equivalent.
