Access Compliance Report

Public Rights-of-Way

(Curb Ramps)

Intersection ID: 14382	Main Street: BROOKHILL_RD	Cross Street: REMUS_RD	Location: W
ADA ID: 8B9AC979FB02	Ramp Type: PerpDiag	Initial Pass/Fail: Fail	Overall Compliance: No
Codes/Mitigation Info/Possible Solution		Field Measurements/Component Compliance	
Severity Score: 33.75

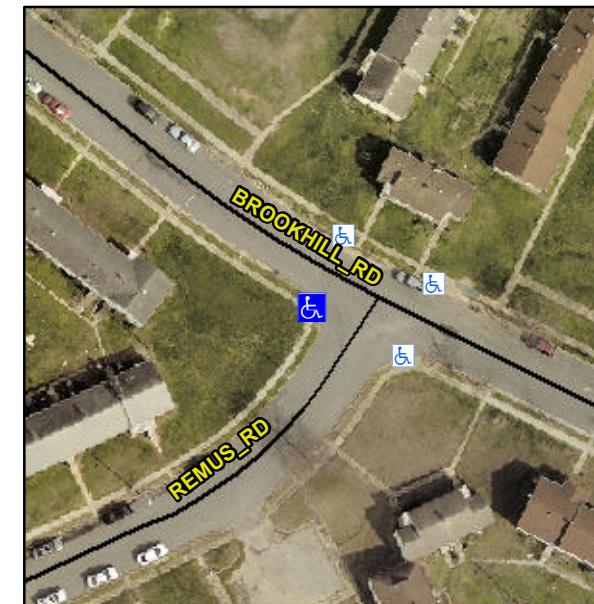
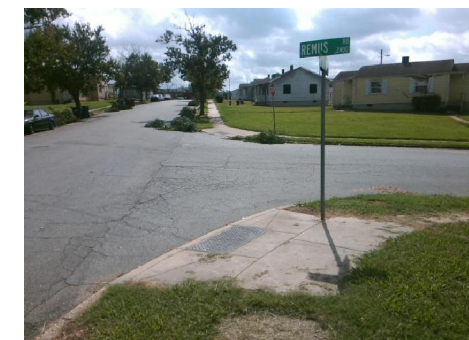
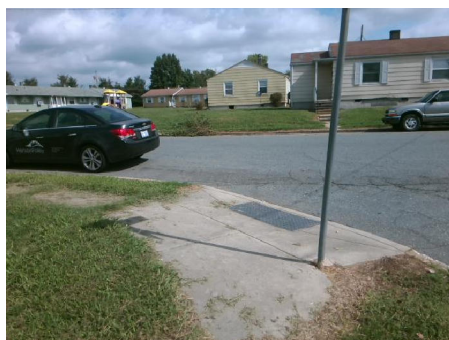
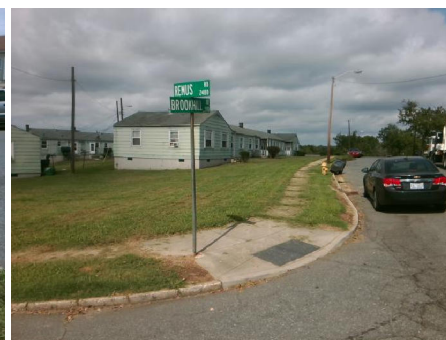
Not Found, R304.5.1, R304.2.2, R304.5.3

Compliance	Description	Data	Compliance	Description	Data
N/A	Ramp Length (in)	89.0	No	Ramp Slope (%)	11.6
No	Ramp Width (in)	41.0	No	Ramp XSlope (%)	6.9
N/A	Flare Type LT	N/A	N/A	Flare Type RT	N/A
N/A	Flare Slope LT (%)	N/A	N/A	Flare Slope RT (%)	N/A
N/A	Flare Traversable LT?	N/A	N/A	Flare Traversable RT?	N/A
N/A	Landing Length (in)	N/A	N/A	DWS Provided?	N/A
N/A	Landing Width (in)	N/A	N/A	DWS Contrast?	N/A
N/A	Landing Slope (%)	N/A	N/A	DWS Length (in)	N/A
N/A	Landing X Slope (%)	N/A	N/A	DWS Full Width?	N/A
N/A	Landing Curb? (Y/N)	N/A	N/A	DWS Offset (in)	N/A
N/A	Shared Landing?	N/A			
N/A	Gutter Ponding?	N/A	N/A	Gutter Slope (%)	N/A
N/A	Gutter Lip Ht (in)	N/A	N/A	Gutter X Slope (%)	N/A
N/A	Painted X Walk1?	No	N/A	Painted X Walk2?	No
	X Walk 1 Direction	To SE		X Walk 2 Direction	To NE
N/A	X Walk 1 Width (in)	N/A	N/A	X Walk 2 Width (in)	N/A
	X Walk 1 Slope (%)	4.1		X Walk 2 Slope (%)	9.3
	X Walk 1 X Slope (%)	7.2		X Walk 2 X Slope (%)	0.8

N/A	Ramp inside XWalk1?	N/A	N/A	Ramp inside XWalk2?	N/A
	Road Slope (%)	3.6	N/A	Clear Space?	N/A
	Road X Slope (%)	9.2	N/A	Clear Space to XWalk (in)	N/A
N/A	Any Obstructions?	N/A	N/A	Storm Grate/Utility Hazard?	N/A
	Obstruction Type			Storm Grate/Utility Type	
		N/A			N/A
			Yes	Surface Condition? (G/P)	Good

Remove & Replace Curb Ramp With Two New Directional Ramps or Equivalent.
