| Intersection ID: 8463 | Main Street: JENNINGS_ST | Cross Street: LASALLE_ST | Location: | SE |
| ADA ID: 8B9BA1795F5D | Ramp Type: Perp | Initial Pass/Fail: Fail | Overall Compliance: No | Severity Score: 21.25 |

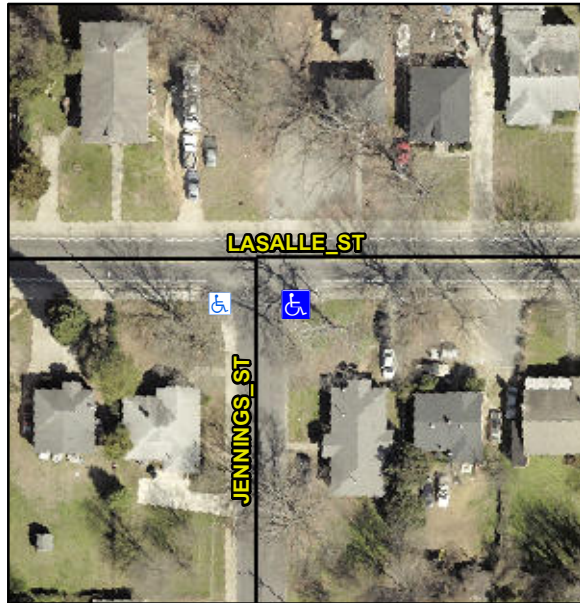
**Not Found, R304.5.1, R304.2.2**

| Compliance | Description | Data | Compliance | Description | Data |
|---|---|---|---|---|---|
| N/A | Ramp Length (in) | 59.5 | No | Ramp Slope (%) | 9.1 |
| No | Ramp Width (in) | 37.0 | Yes | Ramp XSlope (%) | 1.4 |

### Remove & Replace Entire Ramp.
