Access Compliance Report

Public Rights-of-Way

(Curb Ramps)

| Intersection ID: 50866 | Main Street: LAKEVIEW_RD | Cross Street: CUSHING_DR | Location: NE |

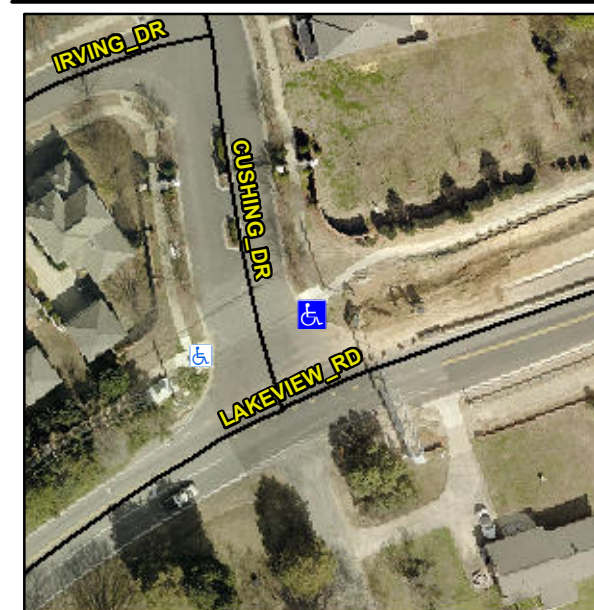
| ADA ID: 8BA0BDC531E7 | Ramp Type: Perp | Initial Pass/Fail: Fail | Overall Compliance: No |
| Severity Score: 22.5 | | | |

R304.5.1, R304.2.2, R304.5.3

| Compliance | Description | Data | Compliance | Description | Data |
|---|---|---|---|---|---|
| N/A | Ramp Length (in) | 77.5 | No | Ramp Slope (%) | 10.0 |
| No | Ramp Width (in) | 47.0 | No | Ramp XSlope (%) | 2.5 |

Remove & Replace Entire Ramp.

\$ 1850.00
