Access Compliance Report

Public Rights-of-Way

(Curb Ramps)

Intersection ID: 43118	Main Street: GRACE_ST	Cross Street: THE_PLAZA	Location:	E
ADA ID: 8BA9B65F3768	Ramp Type: Perp	Initial Pass/Fail: Fail	Overall Compliance: No	Severity Score: 35

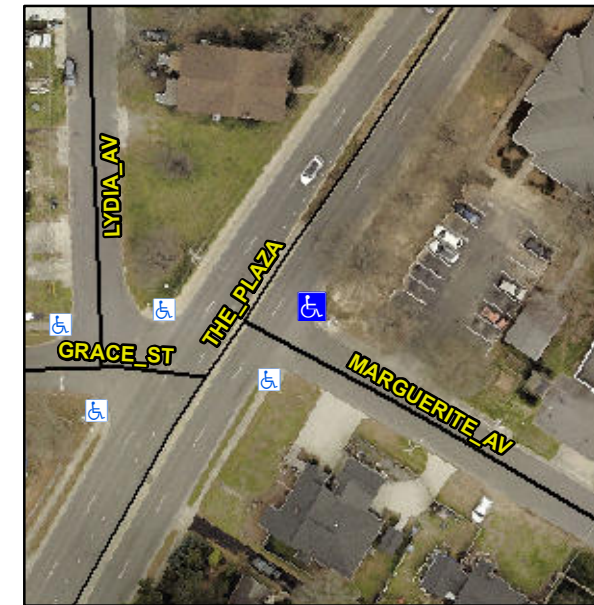
R304.5.1, R304.2.2, R304.5.3

Compliance	Description	Data	Compliance	Description	Data
N/A	Ramp Length (in)	52.0	No	Ramp Slope (%)	12.8
No	Ramp Width (in)	45.0	No	Ramp XSlope (%)	2.4
N/A	Flare Type LT	N/A	N/A	Flare Type RT	N/A
N/A	Flare Slope LT (%)	N/A	N/A	Flare Slope RT (%)	N/A
N/A	Flare Traversable LT?	N/A	N/A	Flare Traversable RT?	N/A
N/A	Landing Length (in)	N/A	N/A	DWS Provided?	N/A
N/A	Landing Width (in)	N/A	N/A	DWS Contrast?	N/A
N/A	Landing Slope (%)	N/A	N/A	DWS Length (in)	N/A
N/A	Landing X Slope (%)	N/A	N/A	DWS Full Width?	N/A
N/A	Landing Curb? (Y/N)	N/A	N/A	DWS Offset (in)	N/A
N/A	Shared Landing?	N/A			
N/A	Gutter Ponding?	N/A	N/A	Gutter Slope (%)	N/A
N/A	Gutter Lip Ht (in)	N/A	N/A	Gutter X Slope (%)	N/A
N/A	Painted X Walk1?	No	N/A	Painted X Walk2?	N/A
	X Walk 1 Direction	To SW		X Walk 2 Direction	N/A
N/A	X Walk 1 Width (in)	N/A	N/A	X Walk 2 Width (in)	N/A
	X Walk 1 Slope (%)	3.3		X Walk 2 Slope (%)	N/A
	X Walk 1 X Slope (%)	0.2		X Walk 2 X Slope (%)	N/A

Remove & Replace Entire Ramp.

Total Cost: \$ 1850.00
