Intersection ID: 18576	Main Street: WAKEFIELD_DR	Cross Street: PINEHURST_PL	Location:	NW
ADA ID: 8BAA3887DC7D	Ramp Type: PerpDiag	Initial Pass/Fail: Fail	Overall Compliance: No	Severity Score: 33.75

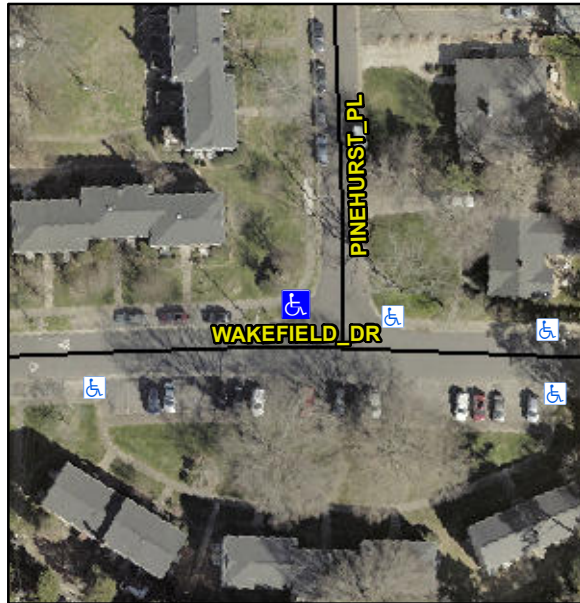
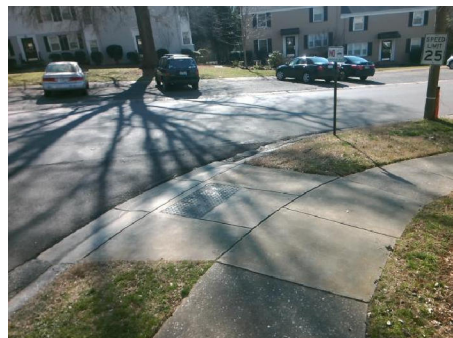
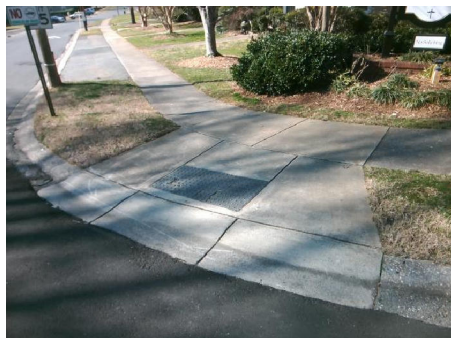
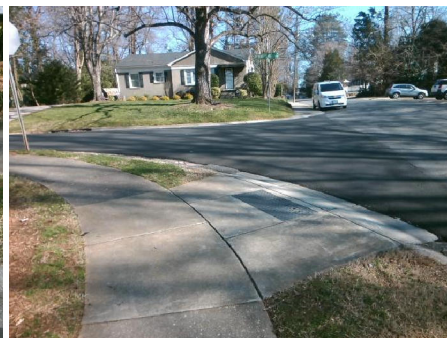
Not Found, R304.5.1, R304.5.3

Compliance	Description	Data	Compliance	Description	Data
N/A	Ramp Length (in)	56.0	Yes	Ramp Slope (%)	0.4
No	Ramp Width (in)	47.5	No	Ramp XSlope (%)	12.0
N/A	Flare Type LT	N/A	N/A	Flare Type RT	N/A
N/A	Flare Slope LT (%)	N/A	N/A	Flare Slope RT (%)	N/A
N/A	Flare Traversable LT?	N/A	N/A	Flare Traversable RT?	N/A
N/A	Landing Length (in)	N/A	N/A	DWS Provided?	N/A
N/A	Landing Width (in)	N/A	N/A	DWS Contrast?	N/A
N/A	Landing Slope (%)	N/A	N/A	DWS Length (in)	N/A
N/A	Landing X Slope (%)	N/A	N/A	DWS Full Width?	N/A
N/A	Landing Curb? (Y/N)	N/A	N/A	DWS Offset (in)	N/A
N/A	Shared Landing?	N/A			
N/A	Gutter Ponding?	N/A	N/A	Gutter Slope (%)	N/A
N/A	Gutter Lip Ht (in)	N/A	N/A	Gutter X Slope (%)	N/A
N/A	Painted X Walk1?	No	N/A	Painted X Walk2?	No
	X Walk 1 Direction	To S		X Walk 2 Direction	To E
N/A	X Walk 1 Width (in)	N/A	N/A	X Walk 2 Width (in)	N/A
	X Walk 1 Slope (%)	0.7		X Walk 2 Slope (%)	13.1
	X Walk 1 X Slope (%)	13.0		X Walk 2 X Slope (%)	1.6

N/A	Ramp inside XWalk1?	N/A	N/A	Ramp inside XWalk2?	N/A
	Road Slope (%)	8.0	N/A	Clear Space?	N/A
	Road X Slope (%)	9.4	N/A	Clear Space to XWalk (in)	N/A
N/A	Any Obstructions?	N/A	N/A	Storm Grate/Utility Hazard?	N/A
	Obstruction Type			Storm Grate/Utility Type	
		N/A			N/A
			Yes	Surface Condition? (G/P)	Good

Remove & Replace Curb Ramp With Two New Directional Ramps or Equivalent.
