# Access Compliance Report

## Public Rights-of-Way

### (Curb Ramps)

Intersection ID: 9830	Main Street: ETHEL_GUEST_LN	Cross Street: GERALDINE_POWE_DR	Location: NE
ADA ID: 8BAD8BE0FDB7	Ramp Type: BlendTrans1	Initial Pass/Fail: Fail	Overall Compliance: No
		Severity Score: 18.75

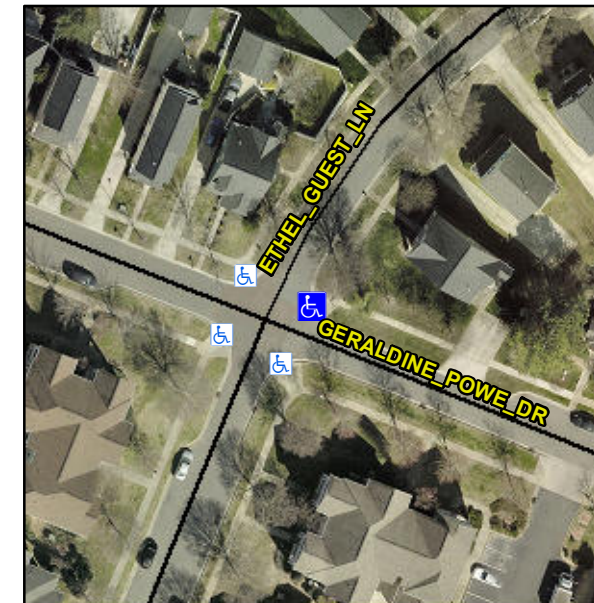
**Not Found, R304.5.1, R304.5.3**

Compliance	Description	Data	Compliance	Description	Data
N/A	Ramp Length (in)	115.0	Yes	BlendTrans Slope (%)	3.4
No	Ramp Width (in)	33.5	No	BlendTrans XSlope (%)	4.9
N/A	Flare Type LT	N/A	N/A	Flare Type RT	N/A
N/A	Flare Slope LT (%)	N/A	N/A	Flare Slope RT (%)	N/A
N/A	Flare Traversable LT?	N/A	N/A	Flare Traversable RT?	N/A
N/A	Landing Length (in)	N/A	N/A	DWS Provided?	N/A
N/A	Landing Width (in)	N/A	N/A	DWS Contrast?	N/A
N/A	Landing Slope (%)	N/A	N/A	DWS Length (in)	N/A
N/A	Landing X Slope (%)	N/A	N/A	DWS Full Width?	N/A
N/A	Landing Curb? (Y/N)	N/A	N/A	DWS Offset (in)	N/A
N/A	Shared Landing?	N/A			
N/A	Gutter Ponding?	N/A	N/A	Gutter Slope (%)	N/A
N/A	Gutter Lip Ht (in)	N/A	N/A	Gutter X Slope (%)	N/A
N/A	Painted X Walk1?	No	N/A	Painted X Walk2?	No
	X Walk 1 Direction	To W		X Walk 2 Direction	To S
	X Walk 1 Width (in)	N/A		X Walk 2 Width (in)	N/A
	X Walk 1 Slope (%)	0.5		X Walk 2 Slope (%)	2.5
	X Walk 1 X Slope (%)	3.3		X Walk 2 X Slope (%)	0.1

N/A	Ramp inside XWalk1?	N/A	N/A	Ramp inside XWalk2?	N/A
	Road Slope (%)	2.7		Clear Space?	N/A
	Road X Slope (%)	2.2	N/A	Clear Space to XWalk (in)	N/A
N/A	Any Obstructions?	N/A	N/A	Storm Grate/Utility Hazard?	N/A
	Obstruction Type			Storm Grate/Utility Type	
		N/A			N/A
			Yes	Surface Condition? (G/P)	Good
			No	Curb Slope (%)	8.8

**Remove & Replace Curb Ramp With Two New Directional Ramps or Equivalent.**
