# Access Compliance Report

## Public Rights-of-Way

### (Curb Ramps)

| Intersection ID: 43685 | Main Street: HARLINGTON_LN | Cross Street: TODDINGTON_LN | Location: | NE |

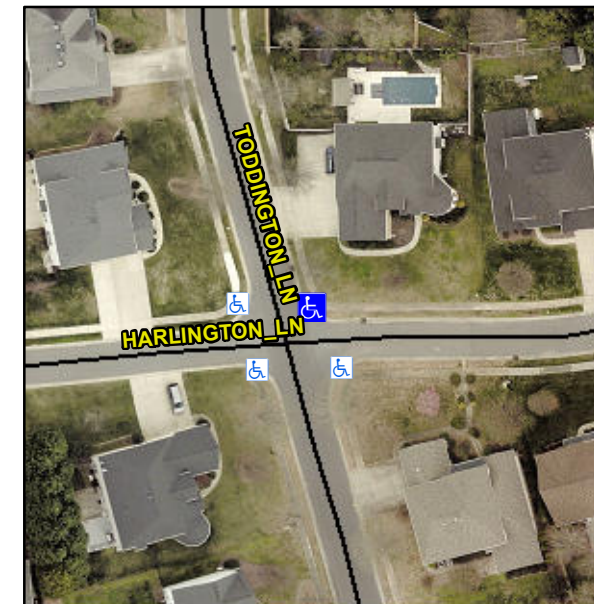
| ADA ID: 8BB18F5EF50F | Ramp Type: BlendTrans1 | Initial Pass/Fail: Fail | Overall Compliance: No | Severity Score: 10 |

**Not Found, R304.5.1, R304.5.3**

| Compliance | Description | Data | Compliance | Description | Data |
|---|---|---|---|---|---|
| No | Ramp Width (in) | 46.0 | No | BlendTrans XSlope (%) | 2.3 |

**Remove & Replace Curb Ramp With Two New Directional Ramps or Equivalent.**
