## Access Compliance Report Public Rights-of-Way (Curb Ramps)

Intersection ID: 4937Main Street:CASTLEMAINE\_DRCross Street:GRANARD\_LNLocation:SEADA ID: 8BC24E8E4AFARamp Type:PerpInitial Pass/Fail:FailOverall Compliance:NoSeverity Score:50

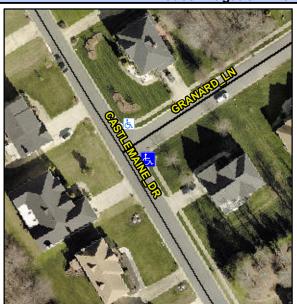
Field Measurements/Component Compliance							
Comp	liance Description	Data	Comp	liance Description	Data		
N/A	Ramp Length (in)	49.0	No	Ramp Slope (%)	12.8		
Yes	Ramp Width (in)	75.0	No	Ramp XSlope (%)	14.0		
N/A	Flare Type LT	N/A	N/A	Flare Type RT	N/A		
N/A	Flare Slope LT (%)	N/A	N/A	Flare Slope RT (%)	N/A		
N/A	Flare Traversable LT?	N/A	N/A	Flare Traversable RT?	N/A		
N/A	Landing Length (in)	N/A	N/A	DWS Provided?	N/A		
N/A	Landing Width (in)	N/A	N/A	DWS Contrast?	N/A		
N/A	Landing Slope (%)	N/A	N/A	DWS Length (in)	N/A		
N/A	Landing X Slope (%)	N/A	N/A	DWS Full Width?	N/A		
N/A	Landing Curb? (Y/N)	N/A	N/A	DWS Offset (in)	N/A		
N/A	Shared Landing?	N/A					
N/A	Gutter Ponding?	N/A	N/A	Gutter Slope (%)	N/A		
N/A	Gutter Lip Ht (in)	N/A	N/A	Gutter X Slope (%)	N/A		
N/A	Painted X Walk1?	No	N/A	Painted X Walk2?	N/A		
	X Walk 1 Direction	To N		X Walk 2 Direction	N/A		
N/A	X Walk 1 Width (in)	N/A	N/A	X Walk 2 Width (in)	N/A

X Walk 1 Slope (%)	8.6		X Walk 2 Slope (%)	N/A		
	X Walk 1 X Slope (%)	8.3		X Walk 2 X Slope (%)	N/A		
N/A	Ramp inside XWalk1?	N/A	N/A	Ramp inside XWalk2?	N/A		
	Road Slope (%)	N/A	N/A	Clear Space?	N/A		
	Road X Slope (%)	N/A	N/A	Clear Space to XWalk (in)	N/A		
N/A	Any Obstructions?	N/A	N/A	Storm Grate/Utility Hazard?	N/A		
	Obstruction Type			Storm Grate/Utility Type			
		N/A			N/A		
			Yes	Surface Condition? (G/P)	Good		
444

Possible Solutions:	<u>c</u>
Remove & Replace Entire Ramp.	N
·	Y
	N
	N
	N
	N
Surveyor Notes:	N
N/A	N
	N
	N
	N
PROW/ADA:	N
Not Found, R304.2.2, R304.5.3	N
	N
	N
