Access Compliance Report

Public Rights-of-Way

| Intersection ID: 21992 | Main Street: WESTINGHOUSE_BV | Cross Street: S_TRYON_ST | Location: NW |
| ADA ID: 8BC2647E129B | Ramp Type: Perp | Initial Pass/Fail: Fail | Overall Compliance: No |

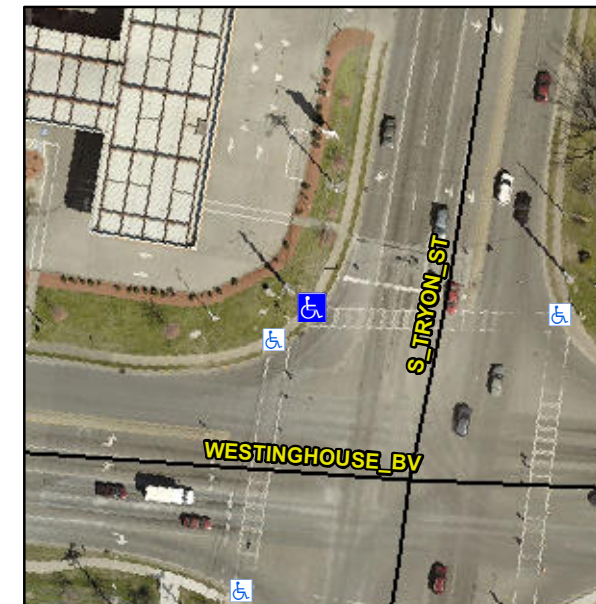
| Codes/Mitigation Info/Possible Solution | | | Severity Score: 22.5 |

Not Found, R304.5.1, R304.2.2, R304.5.3

| Compliance | Description | Data | Compliance | Description | Data |
|---|---|---|---|---|---|
| N/A | Ramp Length (in) | 91.0 | No | Ramp Slope (%) | 9.4 |
| No | Ramp Width (in) | 41.0 | No | Ramp XSlope (%) | 2.9 |

Remove & Replace Entire Ramp.
