Intersection ID: 12681	Main Street: PALOVERDE_LN	Cross Street: PENCE_RD	Location:	SE
ADA ID: 8BC75C26BF66	Ramp Type: PerpDiag	Initial Pass/Fail: Fail	Overall Compliance: No	Severity Score: 26.25

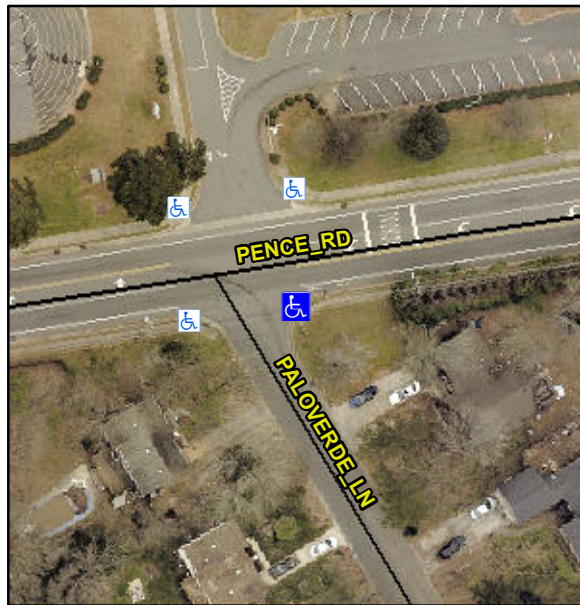
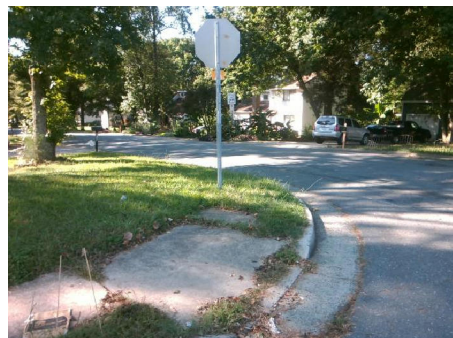
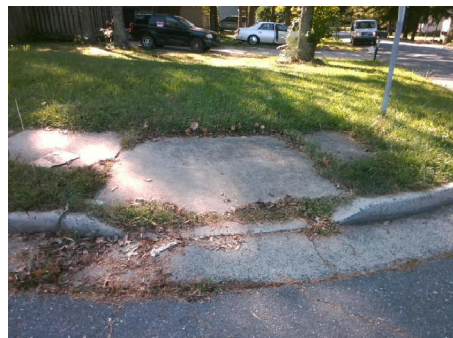
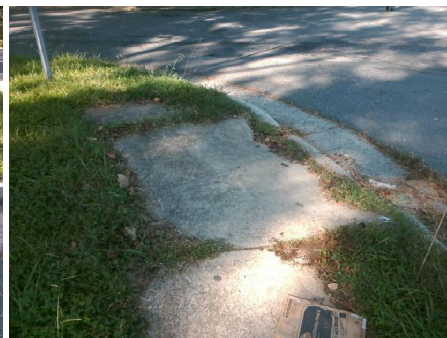
R304.2.2, R304.5.3

Compliance	Description	Data	Compliance	Description	Data
N/A	Ramp Length (in)	20.0	No	Ramp Slope (%)	15.0
Yes	Ramp Width (in)	60.0	No	Ramp XSlope (%)	2.4
N/A	Flare Type LT	N/A	N/A	Flare Type RT	N/A
N/A	Flare Slope LT (%)	N/A	N/A	Flare Slope RT (%)	N/A
N/A	Flare Traversable LT?	N/A	N/A	Flare Traversable RT?	N/A
N/A	Landing Length (in)	N/A	N/A	DWS Provided?	N/A
N/A	Landing Width (in)	N/A	N/A	DWS Contrast?	N/A
N/A	Landing Slope (%)	N/A	N/A	DWS Length (in)	N/A
N/A	Landing X Slope (%)	N/A	N/A	DWS Full Width?	N/A
N/A	Landing Curb? (Y/N)	N/A	N/A	DWS Offset (in)	N/A
N/A	Shared Landing?	N/A			
N/A	Gutter Ponding?	N/A	N/A	Gutter Slope (%)	N/A
N/A	Gutter Lip Ht (in)	2.0	N/A	Gutter X Slope (%)	N/A
N/A	Painted X Walk1?	No	N/A	Painted X Walk2?	No
	X Walk 1 Direction	To N		X Walk 2 Direction	To W
N/A	X Walk 1 Width (in)	N/A	N/A	X Walk 2 Width (in)	N/A
	X Walk 1 Slope (%)	6.2		X Walk 2 Slope (%)	0.1
	X Walk 1 X Slope (%)	2.6		X Walk 2 X Slope (%)	4.0

N/A	Ramp inside XWalk1?	N/A	N/A	Ramp inside XWalk2?	N/A
	Road Slope (%)	4.1	N/A	Clear Space?	N/A
	Road X Slope (%)	5.0	N/A	Clear Space to XWalk (in)	N/A
N/A	Any Obstructions?	N/A	N/A	Storm Grate/Utility Hazard?	N/A
	Obstruction Type			Storm Grate/Utility Type	
		N/A			N/A
			Yes	Surface Condition? (G/P)	Good

Remove & Replace Curb Ramp With Two New Directional Ramps or Equivalent.
