Access Compliance Report

Public Rights-of-Way

(Curb Ramps)

Intersection ID: 3215	Main Street: BELLMORE_CT	Cross Street: OLD_BRIDGE_LN	Location:	W
ADA ID: 8BCCCB96350F	Ramp Type: Perp	Initial Pass/Fail: Fail	Overall Compliance: No	Severity Score: 25
Codes/Mitigation Info/Possible Solution		Field Measurements/Component Compliance

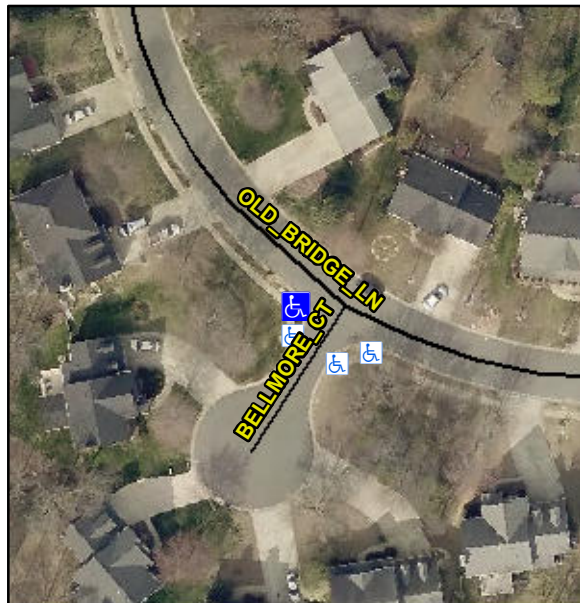
Compliance	Description	Data	Compliance	Description	Data
N/A	Ramp Length (in)	94.0	Yes	Ramp Slope (%)	6.2
Yes	Ramp Width (in)	75.0	No	Ramp XSlope (%)	7.4
N/A	Flare Type LT	N/A	N/A	Flare Type RT	N/A
N/A	Flare Slope LT (%)	N/A	N/A	Flare Slope RT (%)	N/A
N/A	Flare Traversable LT?	N/A	N/A	Flare Traversable RT?	N/A
N/A	Landing Length (in)	N/A	N/A	DWS Provided?	N/A
N/A	Landing Width (in)	N/A	N/A	DWS Contrast?	N/A
N/A	Landing Slope (%)	N/A	N/A	DWS Length (in)	N/A
N/A	Landing X Slope (%)	N/A	N/A	DWS Full Width?	N/A
N/A	Landing Curb? (Y/N)	N/A	N/A	DWS Offset (in)	N/A
N/A	Shared Landing?	N/A			
N/A	Gutter Ponding?	N/A	N/A	Gutter Slope (%)	N/A
N/A	Gutter Lip Ht (in)	N/A	N/A	Gutter X Slope (%)	N/A
N/A	Painted X Walk1?	No	N/A	Painted X Walk2?	N/A
	X Walk 1 Direction	To NE		X Walk 2 Direction	N/A
N/A	X Walk 1 Width (in)	N/A	N/A	X Walk 2 Width (in)	N/A
	X Walk 1 Slope (%)	7.5		X Walk 2 Slope (%)	N/A
	X Walk 1 X Slope (%)	1.3		X Walk 2 X Slope (%)	N/A

N/A	Ramp inside XWalk1?	N/A	N/A	Ramp inside XWalk2?	N/A
	Road Slope (%)	N/A	N/A	Clear Space?	N/A
	Road X Slope (%)	N/A	N/A	Clear Space to XWalk (in)	N/A
N/A	Any Obstructions?	N/A	N/A	Storm Grate/Utility Hazard?	N/A
	Obstruction Type			Storm Grate/Utility Type	
		N/A			N/A
			Yes	Surface Condition? (G/P)	Good

Possible Solutions:

Remove & Replace Entire Ramp.
