Access Compliance Report Public Rights-of-Way (Curb Ramps)

Intersection ID: 10034489 Main Street: PINEBURR RD **Cross Street: N/A** Location: NE ADA ID: 8BDBD52FA9D9 Ramp Type: BlendTrans2 Initial Pass/Fail: Fail **Overall Compliance: No Severity Score:** 12.5

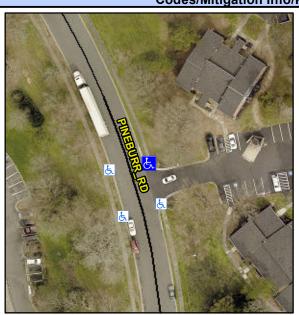
Field Measurements/Component Compliance						
	Comp	liance Description	Data	Compliance Description		Data
	N/A	Ramp Length (in)	34.0	Yes	BlendTrans Slope (%)	0.5
	Yes	Ramp Width (in)	48.0	No	BlendTrans XSlope (%)	5.7
	N/A	Flare Type LT	N/A	N/A	Flare Type RT	N/A
	N/A	Flare Slope LT (%)	N/A	N/A	Flare Slope RT (%)	N/A
	N/A	Flare Traversable LT?	N/A	N/A	Flare Traversable RT?	N/A
	N/A	Landing Length (in)	N/A	N/A	DWS Provided?	N/A
	N/A	Landing Width (in)	N/A	N/A	DWS Contrast?	N/A
	N/A	Landing Slope (%)	N/A	N/A	DWS Length (in)	N/A
	N/A	Landing X Slope (%)	N/A	N/A	DWS Full Width?	N/A
	N/A	Landing Curb? (Y/N)	N/A	N/A	DWS Offset (in)	N/A
	N/A	Shared Landing?	N/A			
	N/A	Gutter Ponding?	N/A	N/A	Gutter Slope (%)	N/A
	N/A	Gutter Lip Ht (in)	N/A	N/A	Gutter X Slope (%)	N/A
	N/A	Painted X Walk1?	No	N/A	Painted X Walk2?	No
		X Walk 1 Direction	To W		X Walk 2 Direction	To SE
		X Walk 1 Width (in)	N/A		X Walk 2 Width (in)	N/A

X Walk 1 Slope (%)	2.0		X Walk 2 Slope (%)	3.7
		X Walk 1 X Slope (%)	4.7		X Walk 2 X Slope (%)	3.0
	N/A	Ramp inside XWalk1?	N/A	N/A	Ramp inside XWalk2?	N/A
		Road Slope (%)	5.2		Clear Space?	N/A
		Road X Slope (%)	5.7	N/A	Clear Space to XWalk (in)	N/A
	N/A	Any Obstructions?	N/A	N/A	Storm Grate/Utility Hazard?	N/A
		Obstruction Type			Storm Grate/Utility Type	
			N/A			N/A
				Yes	Surface Condition? (G/P)	Good
				No	Curb Slope (%)	22.3
		The second secon

Possible Solutions: Remove & Replace Curb Ramp With **Two New Directional Ramps or** Equivalent. Surveyor Notes: **NO LNDG** PROW/ADA: Not Found, R304.5.3
