# Access Compliance Report

## Public Rights-of-Way

### (Curb Ramps)

Intersection ID: N/A	Main Street: WALNUT_LOOP_RD	Cross Street: WOODBINE_WALK_RD	Location: SE
ADA ID: 8BDD1CD381BD	Ramp Type: Perp	Initial Pass/Fail: Fail	Overall Compliance: No
		Severity Score: 12.5

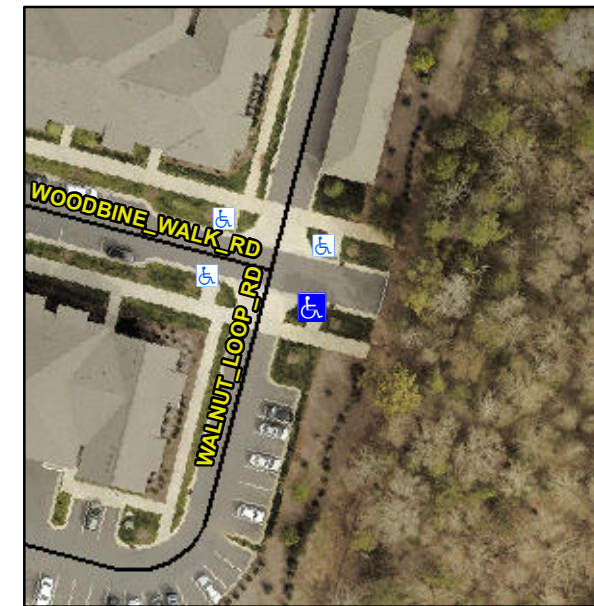
Compliance	Description	Data	Compliance	Description	Data
N/A	Ramp Length (in)	79.0	Yes	Ramp Slope (%)	7.1
Yes	Ramp Width (in)	94.0	No	Ramp XSlope (%)	5.3
N/A	Flare Type LT	N/A	N/A	Flare Type RT	N/A
N/A	Flare Slope LT (%)	N/A	N/A	Flare Slope RT (%)	N/A
N/A	Flare Traversable LT?	N/A	N/A	Flare Traversable RT?	N/A
N/A	Landing Length (in)	N/A	N/A	DWS Provided?	N/A
N/A	Landing Width (in)	N/A	N/A	DWS Contrast?	N/A
N/A	Landing Slope (%)	N/A	N/A	DWS Length (in)	N/A
N/A	Landing X Slope (%)	N/A	N/A	DWS Full Width?	N/A
N/A	Landing Curb? (Y/N)	N/A	N/A	DWS Offset (in)	N/A
N/A	Shared Landing?	N/A			
N/A	Gutter Ponding?	N/A	N/A	Gutter Slope (%)	N/A
N/A	Gutter Lip Ht (in)	N/A	N/A	Gutter X Slope (%)	N/A
N/A	Painted X Walk1?	No	N/A	Painted X Walk2?	N/A
	X Walk 1 Direction	To NE		X Walk 2 Direction	N/A
N/A	X Walk 1 Width (in)	N/A	N/A	X Walk 2 Width (in)	N/A
	X Walk 1 Slope (%)	0.8		X Walk 2 Slope (%)	N/A
	X Walk 1 X Slope (%)	4.9		X Walk 2 X Slope (%)	N/A

N/A	Ramp inside XWalk1?	N/A	N/A	Ramp inside XWalk2?	N/A
	Road Slope (%)	N/A	N/A	Clear Space?	N/A
	Road X Slope (%)	N/A	N/A	Clear Space to XWalk (in)	N/A
N/A	Any Obstructions?	N/A	N/A	Storm Grate/Utility Hazard?	N/A
	Obstruction Type			Storm Grate/Utility Type	
		N/A			N/A
			Yes	Surface Condition? (G/P)	Good

**Remove & Replace Entire Ramp.**

**R304.5.3**

**\$ 1850.00**
