Access Compliance Report

Public Rights-of-Way

(Curb Ramps)

Intersection ID: 9962	Main Street: LITTLE ROCK RD	Cross Street: TUCKASEEGEE RD	Location: S
ADA ID: 8BE4F6FC1C65	Ramp Type: Perp	Initial Pass/Fail: Fail	Overall Compliance: No
Severity Score: 22.5			
Codes/Mitigation Info/Possible Solution		Field Measurements/Component Compliance

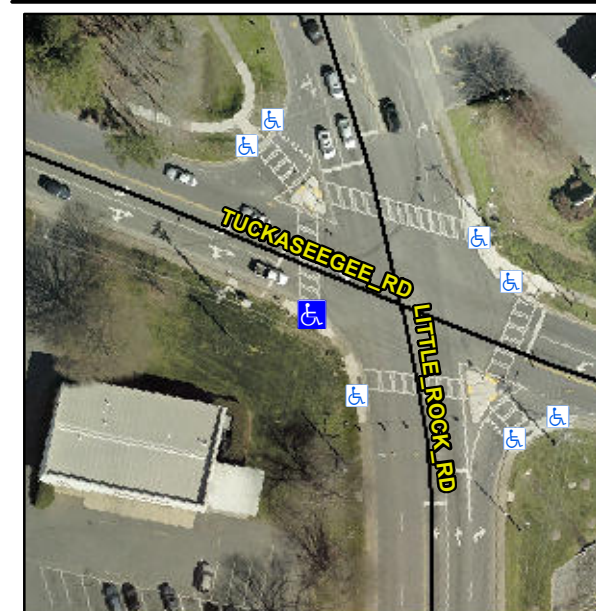
Compliance	Description	Data	Compliance	Description	Data
N/A	Ramp Length (in)	49.0	No	Ramp Slope (%)	10.5
No	Ramp Width (in)	36.0	Yes	Ramp XSlope (%)	2.8
N/A	Flare Type LT	N/A	N/A	Flare Type RT	N/A
N/A	Flare Slope LT (%)	N/A	N/A	Flare Slope RT (%)	N/A
N/A	Flare Traversable LT?	N/A	N/A	Flare Traversable RT?	N/A
N/A	Landing Length (in)	N/A	N/A	DWS Provided?	N/A
N/A	Landing Width (in)	N/A	N/A	DWS Contrast?	N/A
N/A	Landing Slope (%)	N/A	N/A	DWS Length (in)	N/A
N/A	Landing X Slope (%)	N/A	N/A	DWS Full Width?	N/A
N/A	Landing Curb? (Y/N)	N/A	N/A	DWS Offset (in)	N/A
N/A	Shared Landing?	N/A			
N/A	Gutter Ponding?	N/A	N/A	Gutter Slope (%)	N/A
N/A	Gutter Lip Ht (in)	N/A	N/A	Gutter X Slope (%)	N/A
N/A	Painted X Walk1?	No	N/A	Painted X Walk2?	N/A
	X Walk 1 Direction	To NW		X Walk 2 Direction	N/A
N/A	X Walk 1 Width (in)	N/A	N/A	X Walk 2 Width (in)	N/A
	X Walk 1 Slope (%)	2.3		X Walk 2 Slope (%)	N/A
	X Walk 1 X Slope (%)	2.9		X Walk 2 X Slope (%)	N/A

N/A	Ramp inside XWalk1?	N/A	N/A	Ramp inside XWalk2?	N/A
	Road Slope (%)	N/A	N/A	Clear Space?	N/A
	Road X Slope (%)	N/A	N/A	Clear Space to XWalk (in)	N/A
N/A	Any Obstructions?	N/A	N/A	Storm Grate/Utility Hazard?	N/A
	Obstruction Type			Storm Grate/Utility Type	
		N/A			N/A
			Yes	Surface Condition? (G/P)	Good

Possible Solutions:

Remove & Replace Entire Ramp.

R304.5.1, R304.2.2
