Access Compliance Report

Public Rights-of-Way

(Curb Ramps)

Intersection ID: 27595	Main Street: BALLANTYNE COMMONS PY	Cross Street: BALLANTYNE MEADOWS DR	Location: SW
ADA ID: 8BE60407A95B	Ramp Type: Directional1	Initial Pass/Fail: Fail	Overall Compliance: No
Severity Score: 12.5			
Codes/Mitigation Info/Possible Solution		Field Measurements/Component Compliance

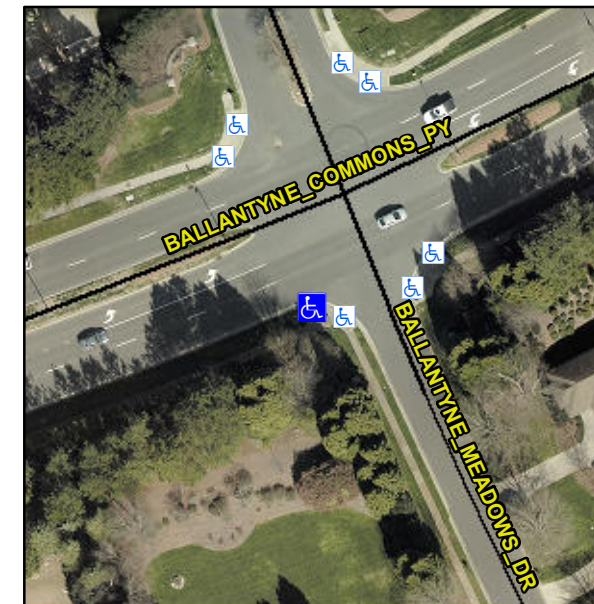
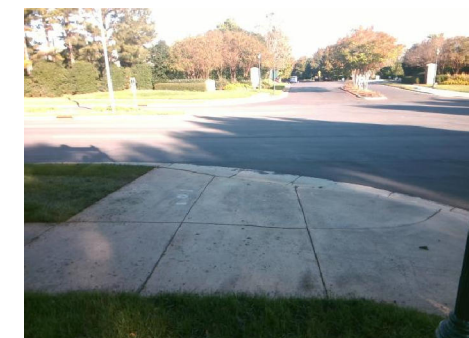
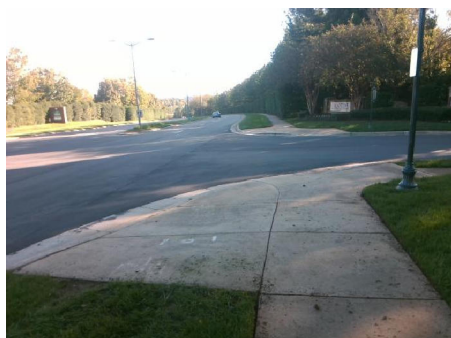
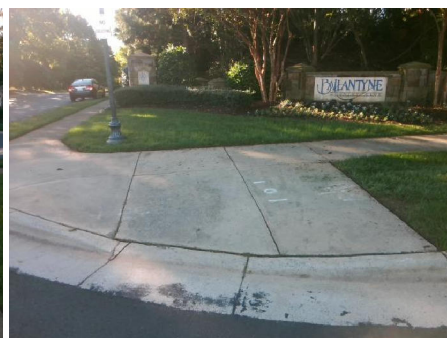
Compliance	Description	Data	Compliance	Description	Data
N/A	Ramp Length (in)	80.0	N/A	Grade Break?	N/A
Yes	Ramp Width (in)	63.0	N/A	Grade Break Slope (%)	0.0
No	Ramp Slope (%)	10.4	N/A	Grade Break XSlope (%)	0.0
Yes	Ramp XSlope (%)	0.9			
N/A	Flare Type LT	N/A	N/A	Flare Type RT	N/A
N/A	Flare Slope LT (%)	N/A	N/A	Flare Slope RT (%)	0.0
N/A	Flare Traversable LT?	N/A	N/A	Flare Traversable RT?	N/A
N/A	Landing Length (in)	0.0	N/A	DWS Provided?	N/A
N/A	Landing Width (in)	0.0	N/A	DWS Contrast?	N/A
N/A	Landing Slope (%)	0.0	N/A	DWS Length (in)	N/A
N/A	Landing X Slope (%)	0.0	N/A	DWS Full Width?	N/A
N/A	Landing Curb? (Y/N)	N/A	N/A	DWS Offset LT (in)	N/A
N/A	Shared Landing?	N/A	N/A	DWS Offset RT (in)	N/A
N/A	Gutter Ponding?	0.0	N/A	Gutter Slope (%)	N/A
N/A	Gutter Lip Ht (in)	0.0	N/A	Gutter X Slope (%)	N/A
N/A	Painted X Walk1?	No		Road Slope (%)	4.7
	X Walk 1 Direction	To NW		Road X Slope (%)	4.2
	X Walk 1 Width (in)	N/A		Clear Space?	N/A

X Walk 1 Slope (%)	4.7	N/A	Clear Space to XWalk (in)	N/A
	X Walk 1 X Slope (%)	4.2	N/A	Storm Grate/Utility Hazard?	N/A
N/A	Ramp inside XWalk1?	N/A		Storm Grate/Utility Type	
N/A	Any Obstructions?	N/A			N/A
	Obstruction Type		Yes	Surface Condition? (G/P)	Good
			N/A	Curb Slope (%)	15.3

Possible Solutions:

Remove & Replace Entire Ramp.

PROW/ADA:

R304.2.2
