Access Compliance Report

Public Rights-of-Way

(Curb Ramps)

Intersection ID: 32024	Main Street: CORNWALLIS_CAMP_DR	Cross Street: STONECROFT_PARK_DR	Location: SE
ADA ID: 8BE9BE094351	Ramp Type: BlendTrans1	Initial Pass/Fail: Fail	Overall Compliance: No
Severity Score: 42.5			
Codes/Mitigation Info/Possible Solution		Field Measurements/Component Compliance

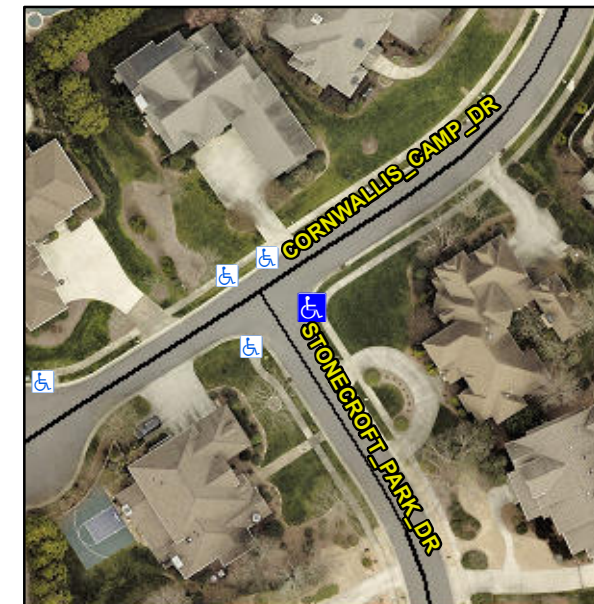
Not Found, R304.5.1, R304.5.3

Compliance	Description	Data	Compliance	Description	Data
N/A	Ramp Length (in)	49.0	Yes	BlendTrans Slope (%)	2.6
No	Ramp Width (in)	34.0	No	BlendTrans XSlope (%)	7.9
N/A	Flare Type LT	N/A	N/A	Flare Type RT	N/A
N/A	Flare Slope LT (%)	N/A	N/A	Flare Slope RT (%)	N/A
N/A	Flare Traversable LT?	N/A	N/A	Flare Traversable RT?	N/A
N/A	Landing Length (in)	N/A	N/A	DWS Provided?	N/A
N/A	Landing Width (in)	N/A	N/A	DWS Contrast?	N/A
N/A	Landing Slope (%)	N/A	N/A	DWS Length (in)	N/A
N/A	Landing X Slope (%)	N/A	N/A	DWS Full Width?	N/A
N/A	Landing Curb? (Y/N)	N/A	N/A	DWS Offset (in)	N/A
N/A	Shared Landing?	N/A			
N/A	Gutter Ponding?	N/A	N/A	Gutter Slope (%)	N/A
N/A	Gutter Lip Ht (in)	N/A	N/A	Gutter X Slope (%)	N/A
N/A	Painted X Walk1?	No	N/A	Painted X Walk2?	No
	X Walk 1 Direction	To NW		X Walk 2 Direction	To SW
	X Walk 1 Width (in)	N/A		X Walk 2 Width (in)	N/A
	X Walk 1 Slope (%)	1.3		X Walk 2 Slope (%)	4.3
	X Walk 1 X Slope (%)	5.7		X Walk 2 X Slope (%)	4.4

N/A	Ramp inside XWalk1?	N/A	N/A	Ramp inside XWalk2?	N/A
	Road Slope (%)	6.1		Clear Space?	N/A
	Road X Slope (%)	1.9	N/A	Clear Space to XWalk (in)	N/A
N/A	Any Obstructions?	N/A	N/A	Storm Grate/Utility Hazard?	N/A
	Obstruction Type			Storm Grate/Utility Type	
		N/A			N/A
			Yes	Surface Condition? (G/P)	Good
			No	Curb Slope (%)	10.1

Remove & Replace Curb Ramp With Two New Directional Ramps or Equivalent.
