# Access Compliance Report

## Public Rights-of-Way

### (Curb Ramps)

Intersection ID: 50250	Main Street: GLANWORTH_CT	Cross Street: DERRYRUSH_DR	Location: NE
ADA ID: 8BEA3961C0C6	Ramp Type: PerpDiag	Initial Pass/Fail: Fail	Overall Compliance: No
Severity Score: 10			
Codes/Mitigation Info/Possible Solution		Field Measurements/Component Compliance

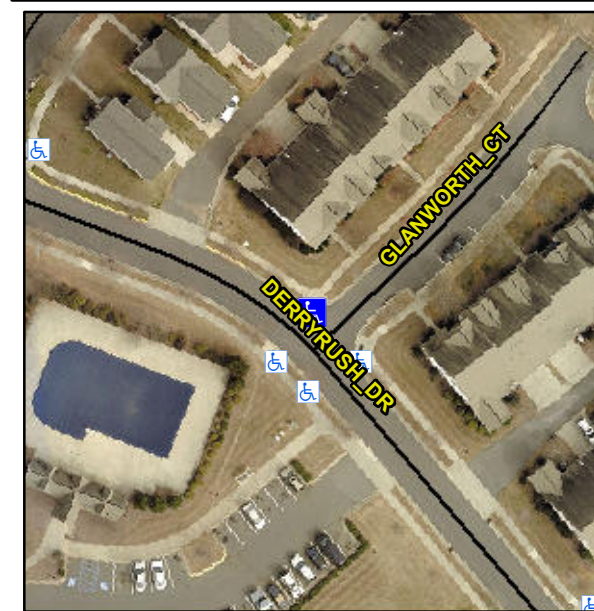
**Not Found, R304.5.1, R304.5.3**

Compliance	Description	Data	Compliance	Description	Data
N/A	Ramp Length (in)	51.0	Yes	Ramp Slope (%)	8.0
No	Ramp Width (in)	42.0	No	Ramp XSlope (%)	3.4
N/A	Flare Type LT	N/A	N/A	Flare Type RT	N/A
N/A	Flare Slope LT (%)	N/A	N/A	Flare Slope RT (%)	N/A
N/A	Flare Traversable LT?	N/A	N/A	Flare Traversable RT?	N/A
N/A	Landing Length (in)	N/A	N/A	DWS Provided?	N/A
N/A	Landing Width (in)	N/A	N/A	DWS Contrast?	N/A
N/A	Landing Slope (%)	N/A	N/A	DWS Length (in)	N/A
N/A	Landing X Slope (%)	N/A	N/A	DWS Full Width?	N/A
N/A	Landing Curb? (Y/N)	N/A	N/A	DWS Offset (in)	N/A
N/A	Shared Landing?	N/A			
N/A	Gutter Ponding?	N/A	N/A	Gutter Slope (%)	N/A
N/A	Gutter Lip Ht (in)	N/A	N/A	Gutter X Slope (%)	N/A
N/A	Painted X Walk1?	No	N/A	Painted X Walk2?	No
	X Walk 1 Direction	To SW		X Walk 2 Direction	To SE
N/A	X Walk 1 Width (in)	N/A	N/A	X Walk 2 Width (in)	N/A
	X Walk 1 Slope (%)	0.1		X Walk 2 Slope (%)	0.9
	X Walk 1 X Slope (%)	2.5		X Walk 2 X Slope (%)	3.0

N/A	Ramp inside XWalk1?	N/A	N/A	Ramp inside XWalk2?	N/A
	Road Slope (%)	2.7	N/A	Clear Space?	N/A
	Road X Slope (%)	1.1	N/A	Clear Space to XWalk (in)	N/A
N/A	Any Obstructions?	N/A	N/A	Storm Grate/Utility Hazard?	N/A
	Obstruction Type			Storm Grate/Utility Type	
		N/A			N/A
			Yes	Surface Condition? (G/P)	Good

**Remove & Replace Curb Ramp With Two New Directional Ramps or Equivalent.**
