# Access Compliance Report

## Public Rights-of-Way

### (Curb Ramps)

Intersection ID: N/A	Main Street: WENDOVER_CR	Cross Street: SHARON_RD	Location: W
ADA ID: 8BEDA740E673	Ramp Type: BlendTrans2	Initial Pass/Fail: Fail	Overall Compliance: No
		Severity Score: 12.5

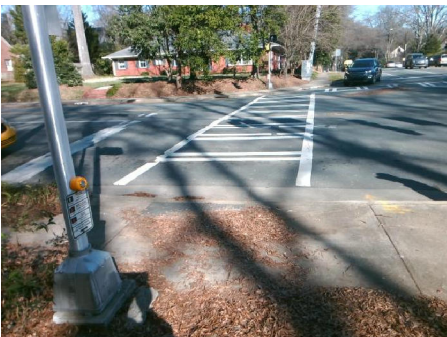
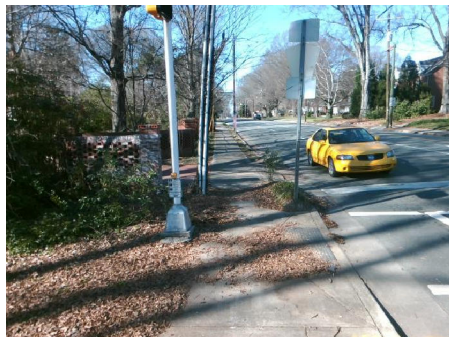
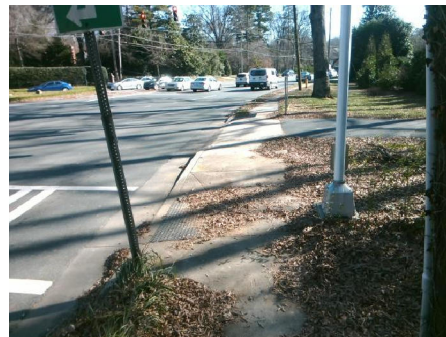
Compliance	Description	Data	Compliance	Description	Data
N/A	Ramp Length (in)	77.0	Yes	BlendTrans Slope (%)	2.8
Yes	Ramp Width (in)	50.0	No	BlendTrans XSlope (%)	5.2
N/A	Flare Type LT	N/A	N/A	Flare Type RT	N/A
N/A	Flare Slope LT (%)	N/A	N/A	Flare Slope RT (%)	N/A
N/A	Flare Traversable LT?	N/A	N/A	Flare Traversable RT?	N/A
N/A	Landing Length (in)	N/A	N/A	DWS Provided?	N/A
N/A	Landing Width (in)	N/A	N/A	DWS Contrast?	N/A
N/A	Landing Slope (%)	N/A	N/A	DWS Length (in)	N/A
N/A	Landing X Slope (%)	N/A	N/A	DWS Full Width?	N/A
N/A	Landing Curb? (Y/N)	N/A	N/A	DWS Offset (in)	N/A
N/A	Shared Landing?	N/A			
N/A	Gutter Ponding?	N/A	N/A	Gutter Slope (%)	N/A
N/A	Gutter Lip Ht (in)	N/A	N/A	Gutter X Slope (%)	N/A
N/A	Painted X Walk1?	Yes	N/A	Painted X Walk2?	N/A
	X Walk 1 Direction	To NE		X Walk 2 Direction	N/A
	X Walk 1 Width (in)	102.0		X Walk 2 Width (in)	N/A
	X Walk 1 Slope (%)	3.2		X Walk 2 Slope (%)	N/A
	X Walk 1 X Slope (%)	3.0		X Walk 2 X Slope (%)	N/A

N/A	Ramp inside XWalk1?	Yes	N/A	Ramp inside XWalk2?	N/A
	Road Slope (%)	3.0		Clear Space?	N/A
	Road X Slope (%)	3.2	N/A	Clear Space to XWalk (in)	N/A
N/A	Any Obstructions?	N/A	N/A	Storm Grate/Utility Hazard?	N/A
	Obstruction Type			Storm Grate/Utility Type	
		N/A			N/A
			Yes	Surface Condition? (G/P)	Good
			N/A	Curb Slope (%)	2.4

**Remove & Replace Curb Ramp With Two New Directional Ramps or Equivalent.**

**R304.5.3**
