Access Compliance Report

Public Rights-of-Way (Curb Ramps)

Intersection ID: 3840	Main Street: CHIMNEY RIDGE TL	Cross Street: DEER CROSS TL	Location: NE
ADA ID: 8BF815323E77	Ramp Type: Directional1	Initial Pass/Fail: Fail	Overall Compliance: No
Severity Score: 8.75			
Codes/Mitigation Info/Possible Solution		Field Measurements/Component Compliance

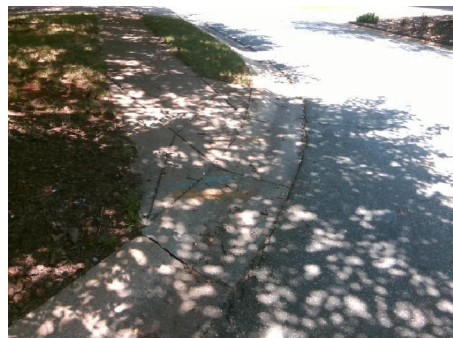
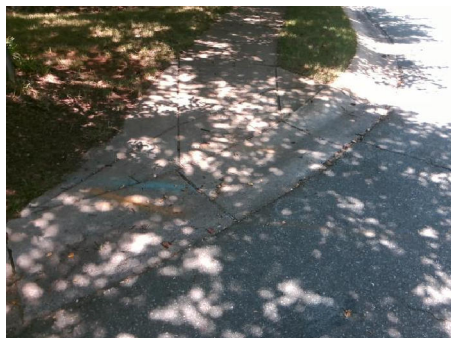
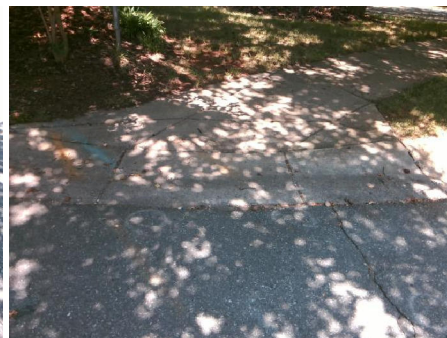
Compliance	Description	Data	Compliance	Description	Data
N/A	Ramp Length (in)	30.0	N/A	Grade Break?	N/A
No	Ramp Width (in)	36.0	N/A	Grade Break Slope (%)	0.0
Yes	Ramp Slope (%)	6.6	N/A	Grade Break XSlope (%)	0.0
Yes	Ramp XSlope (%)	1.7			
N/A	Flare Type LT	N/A	N/A	Flare Type RT	N/A
N/A	Flare Slope LT (%)	N/A	N/A	Flare Slope RT (%)	0.0
N/A	Flare Traversable LT?	N/A	N/A	Flare Traversable RT?	N/A
N/A	Landing Length (in)	0.0	N/A	DWS Provided?	N/A
N/A	Landing Width (in)	0.0	N/A	DWS Contrast?	N/A
N/A	Landing Slope (%)	0.0	N/A	DWS Length (in)	N/A
N/A	Landing X Slope (%)	0.0	N/A	DWS Full Width?	N/A
N/A	Landing Curb? (Y/N)	N/A	N/A	DWS Offset LT (in)	N/A
N/A	Shared Landing?	N/A	N/A	DWS Offset RT (in)	N/A
N/A	Gutter Ponding?	0.0	N/A	Gutter Slope (%)	N/A
N/A	Gutter Lip Ht (in)	0.0	N/A	Gutter X Slope (%)	N/A
N/A	Painted X Walk1?	No		Road Slope (%)	1.8
	X Walk 1 Direction	To W		Road X Slope (%)	5.1
	X Walk 1 Width (in)	N/A		Clear Space?	N/A

X Walk 1 Slope (%)	1.8	N/A	Clear Space to XWalk (in)	N/A
	X Walk 1 X Slope (%)	5.1	N/A	Storm Grate/Utility Hazard?	N/A
N/A	Ramp inside XWalk1?	N/A		Storm Grate/Utility Type	
N/A	Any Obstructions?	N/A			N/A
	Obstruction Type		Yes	Surface Condition? (G/P)	Good
			N/A	Curb Slope (%)	5.2

Possible Solutions:

Remove & Replace Entire Ramp.
