Access Compliance Report

Public Rights-of-Way

(Curb Ramps)

| Intersection ID: 6957 | Main Street: N_TRYON_ST | Cross Street: N_US_29_BY-PASS_HY | Location: NW |

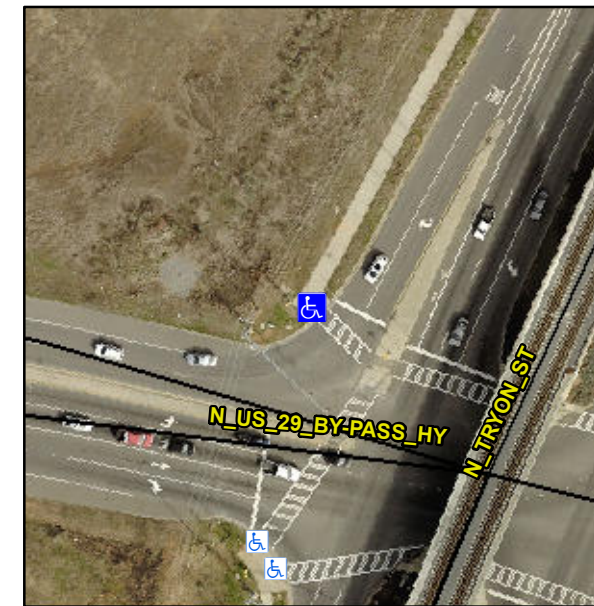
| ADA ID: 8BFA7D3F4017 | Ramp Type: Perp | Initial Pass/Fail: Fail | Overall Compliance: No |
| | | | Severity Score: 21.25 |

Not Found, R304.5.1, R304.5.3

| Compliance | Description | Data | Compliance | Description | Data |
|---|---|---|---|---|---|
| No | Ramp Width (in) | 47.5 | No | Ramp XSlope (%) | 5.9 |

Possible Solutions:

Remove & Replace Entire Ramp.

Total Cost: \$ 1850.00
