Access Compliance Report

Public Rights-of-Way

(Curb Ramps)

Intersection ID: 10020377	Main Street: BALLANTYNE CORPORATE PL	Cross Street: N/A	Location: NW
ADA ID: 8C131049BC6E	Ramp Type: Perp	Initial Pass/Fail: Fail	Overall Compliance: No
Severity Score: 12.5			
Codes/Mitigation Info/Possible Solution		Field Measurements/Component Compliance

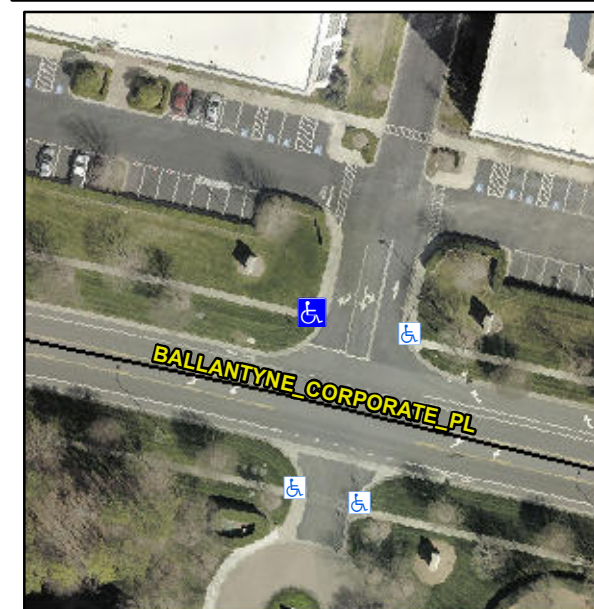
Not Found, R304.2.2

Compliance	Description	Data	Compliance	Description	Data
N/A	Ramp Length (in)	51.0	No	Ramp Slope (%)	10.5
Yes	Ramp Width (in)	48.0	Yes	Ramp XSlope (%)	1.0
N/A	Flare Type LT	N/A	N/A	Flare Type RT	N/A
N/A	Flare Slope LT (%)	N/A	N/A	Flare Slope RT (%)	N/A
N/A	Flare Traversable LT?	N/A	N/A	Flare Traversable RT?	N/A
N/A	Landing Length (in)	N/A	N/A	DWS Provided?	N/A
N/A	Landing Width (in)	N/A	N/A	DWS Contrast?	N/A
N/A	Landing Slope (%)	N/A	N/A	DWS Length (in)	N/A
N/A	Landing X Slope (%)	N/A	N/A	DWS Full Width?	N/A
N/A	Landing Curb? (Y/N)	N/A	N/A	DWS Offset (in)	N/A
N/A	Shared Landing?	N/A			
N/A	Gutter Ponding?	N/A	N/A	Gutter Slope (%)	N/A
N/A	Gutter Lip Ht (in)	N/A	N/A	Gutter X Slope (%)	N/A
N/A	Painted X Walk1?	No	N/A	Painted X Walk2?	N/A
	X Walk 1 Direction	To SE		X Walk 2 Direction	N/A
N/A	X Walk 1 Width (in)	N/A	N/A	X Walk 2 Width (in)	N/A
	X Walk 1 Slope (%)	1.5		X Walk 2 Slope (%)	N/A
	X Walk 1 X Slope (%)	2.9		X Walk 2 X Slope (%)	N/A

N/A	Ramp inside XWalk1?	N/A	N/A	Ramp inside XWalk2?	N/A
	Road Slope (%)	N/A	N/A	Clear Space?	N/A
	Road X Slope (%)	N/A	N/A	Clear Space to XWalk (in)	N/A
N/A	Any Obstructions?	N/A	N/A	Storm Grate/Utility Hazard?	N/A
	Obstruction Type			Storm Grate/Utility Type	
		N/A			N/A
			Yes	Surface Condition? (G/P)	Good

Possible Solutions:

Remove & Replace Entire Ramp.
